Dublin City Cycle Scheme "dublinbikes"

Stage 3 Road Safety Audit

November 2009

Halcrow Barry

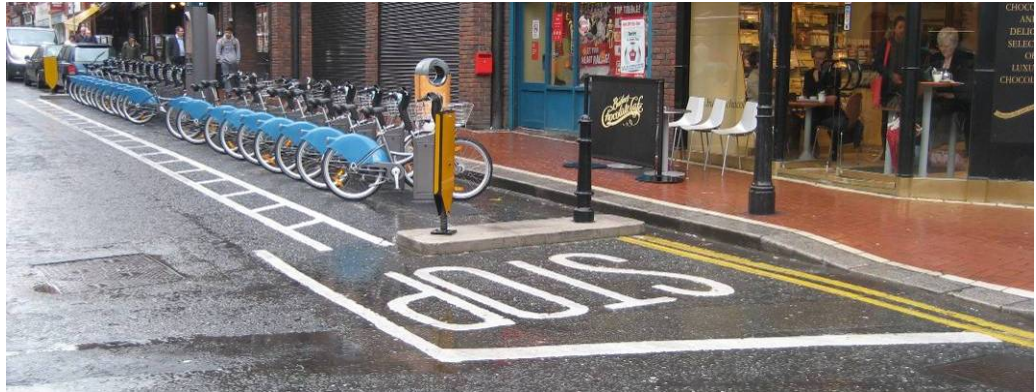
2.1 Site 1 (1B) Chatham Street

Due to the proximity of the cycle stand termination with the adjacent junction, there remains insufficient space for a vehicle to address the Stop line without crossing into the opposing traffic lane. This could result in head on type vehicle conflicts.

Provide sufficient road space to allow a vehicle to address the Stop line without crossing into the opposing traffic lane.

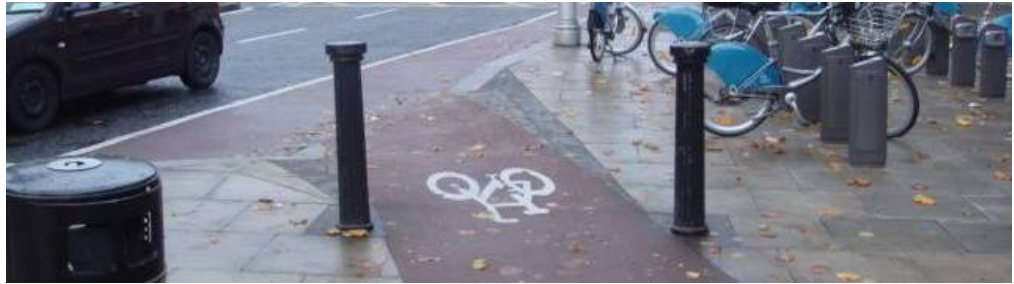
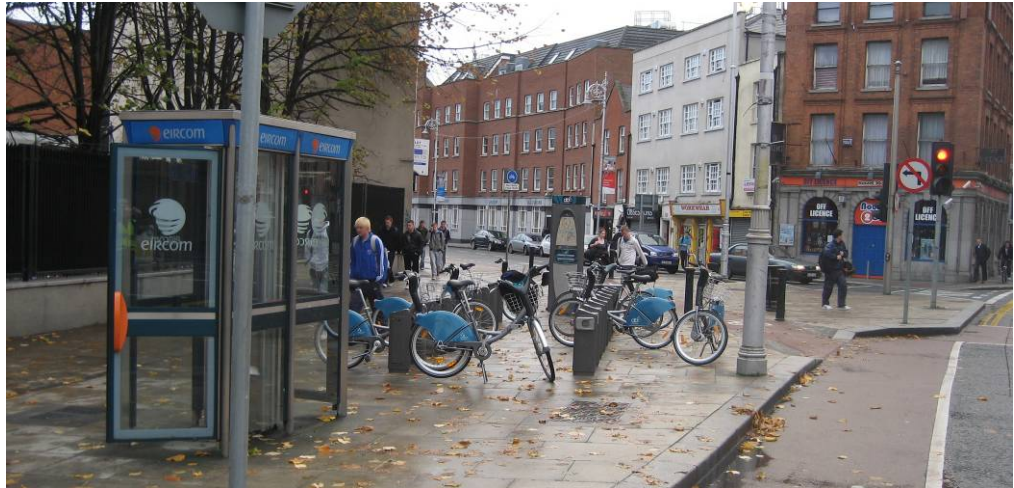
2.3 Site 3 (3) Bolton Street

The bollards located either side of the existing cycle path present obstructions which could be struck by cyclists and/or visually impaired pedestrians.

Mount/fit reflective material on the bollards to provide a high level of visual contrast with their immediate surroundings. This will serve to highlight the bollards presence to cyclists and visually impaired road users.

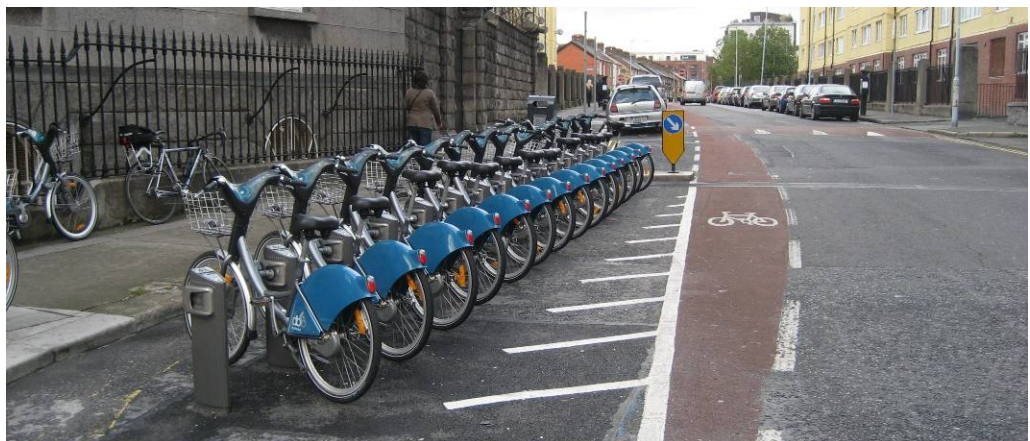
2.4 Site 4 (4) Greek Street

Service vehicles which park directly adjacent to the cycle station on Greek Street could block the one-way traffic stream, leading to queue blocking at the junction of Chancery Street / Greek Street.

The adjacent advisory cycle track markings are worn and difficult for motorists to see. This could result in conflicts between vehicular traffic and cyclists.

Service vehicles should not be permitted to park adjacent to the cycle station on Greek Street.

Replace/renew the adjacent advisory cycle track markings.

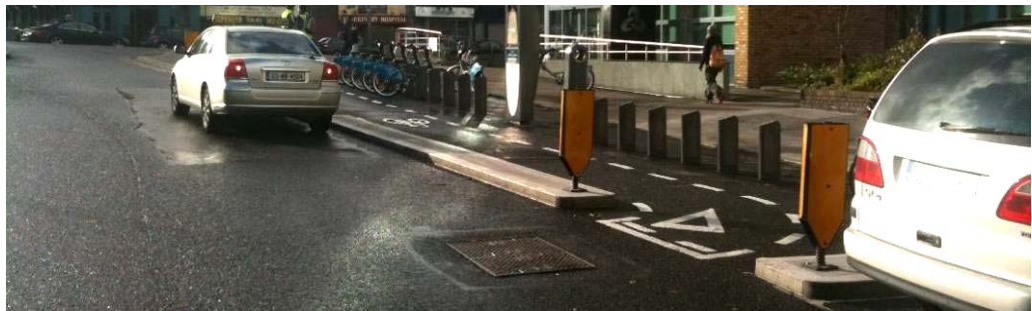
Site 5 (5B) Charlemont Place

An existing manhole lid is positioned on Charlemont Place directly at the point of exit from the cycle station. Manhole covers in the road can cause problems for two wheelers, as the grip between the cast iron cover and the bicycle's tyres can be less than that of the surrounding road surface. This could cause a bicycle's tyres to slip or skid, leading to the risk of injury for a cyclist.

Relocate the manhole cover away from the cycle station exit point. If this is not possible then replace it either with a recess manhole cover in-filled with wearing course or a manhole cover with a high friction surface.

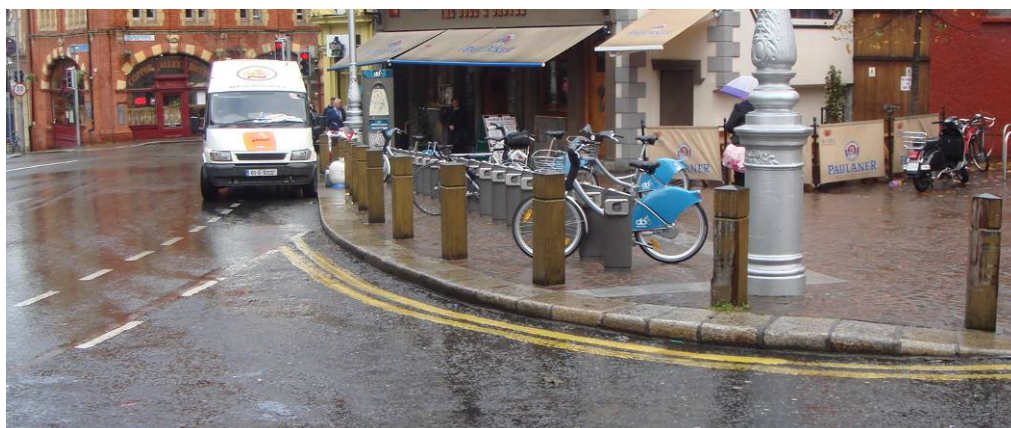
Site 6 (6A) Christchurch Place

Service vehicles which park directly adjacent to the cycle station on Christchurch Place or at the junction of Christchurch Place/ Castle Street could serve to impede the safe passage of both vehicular traffic and vulnerable road users.

Ensure that service vehicles do not park directly adjacent to the cycle station on Christchurch Place or at the one-way junction of Christchurch Place/ Castle Street.

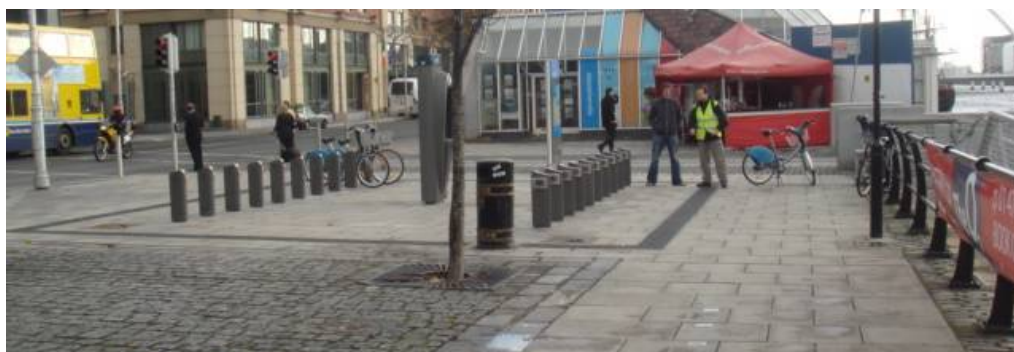
Site 8 (8) Custom House Quay

In close proximity to the cycle station, a signal controlled pedestrian crossing services footfall bound to/from Sean O' Casey Bridge as it crosses Custom House Quay.

The potential remains for service vehicles to block the pedestrian crossing or block forward visibility to the pedestrian crossing and its traffic signals. This could result in conflict between vulnerable road users and vehicular traffic.

Ensure that service vehicles are not permitted to stop in such a position which blocks the pedestrian crossing or limits forward visibility to the pedestrian crossing point and/or the crossings traffic signals.

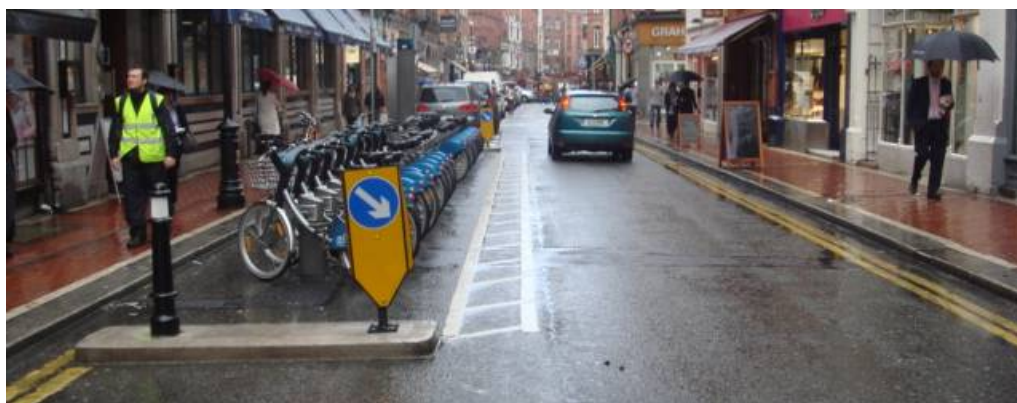
2.9 Site 9 (9B) Exchequer Street

There is a risk that a service vehicle parked on Exchequer Street (which is one-way) adjacent to the cycle station will cause a traffic obstruction.

Ensure that service vehicles do not park in such a manner which impedes the safe progression of vulnerable road users and also vehicular traffic.

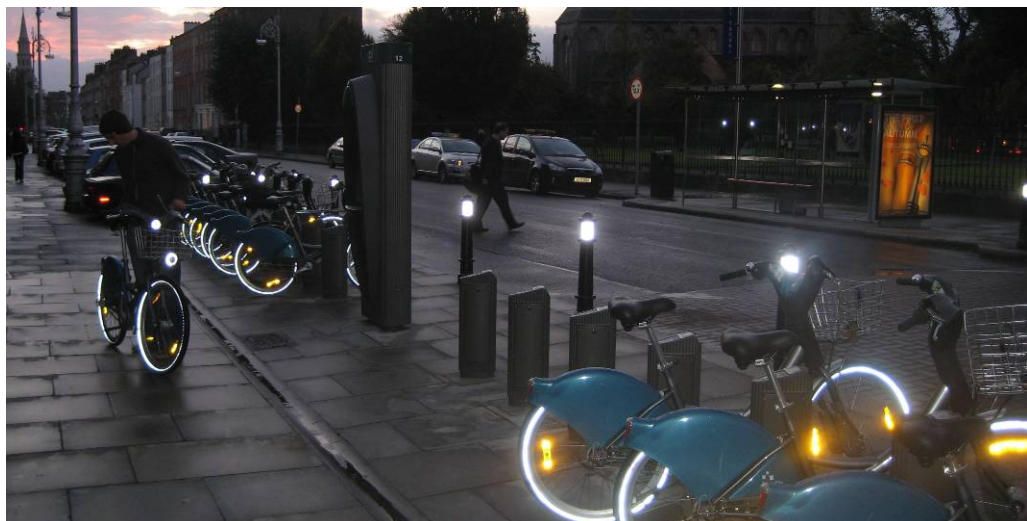
2.12 Site 12 (12) Eccles Street

Service vehicle parking at the Berkeley Road junction may obstruct the raised platform, forcing traffic turning from Berkeley Road onto Eccles Street into the opposing lane resulting in potential vehicle conflicts and forcing mobility impaired road users to negotiate the raised kerbs either side of the platform resulting in potential trips/falls.

Ensure that service vehicles do not obstruct the raised platform at the Berkeley Road junction.

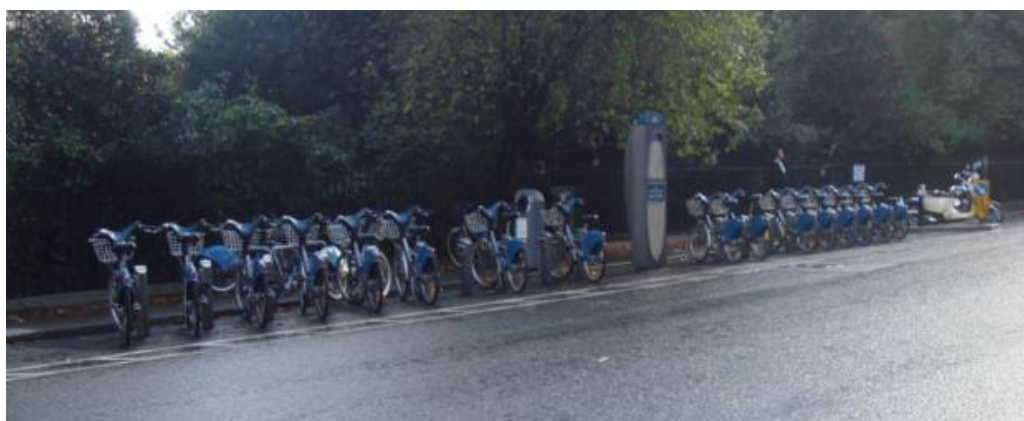
2.13 Site 13 (13) Fitzwilliam Square West

During the night time visit, the area surrounding the cycle station appeared to be adequately lit, however the Auditor noted that the bourse itself was overshadowed by an overhanging tree.

The footpath at the cycle station location has a raised section which creates a step between the footpath and the road pavement. This could potentially create a trip hazard for partially sighted road users.

Cut back the branches of the tree to ensure the entire station is adequately lit at night.

Highlight the presence of the potential trip hazard by applying a contrasting colour to the nosing of the step.

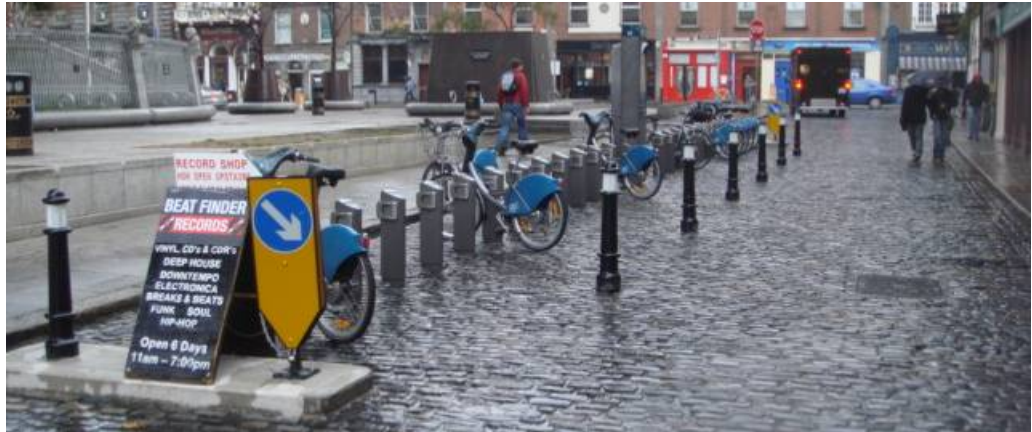
2.14 Site 14 (14A) Fownes Street Upper

Service vehicles parked on Fownes Street Upper in close proximity to the Dame Street junction will cause a traffic obstruction on Fownes Street Upper.

Ensure service vehicles do not park within 20 metres of the junction of Dame Street and Fownes Street Upper.

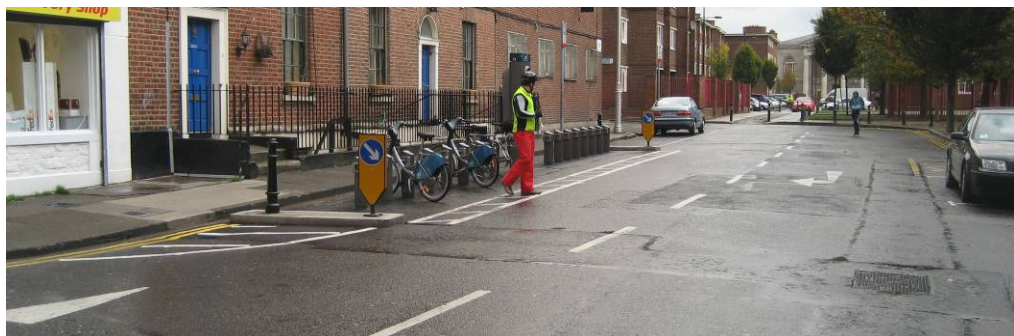
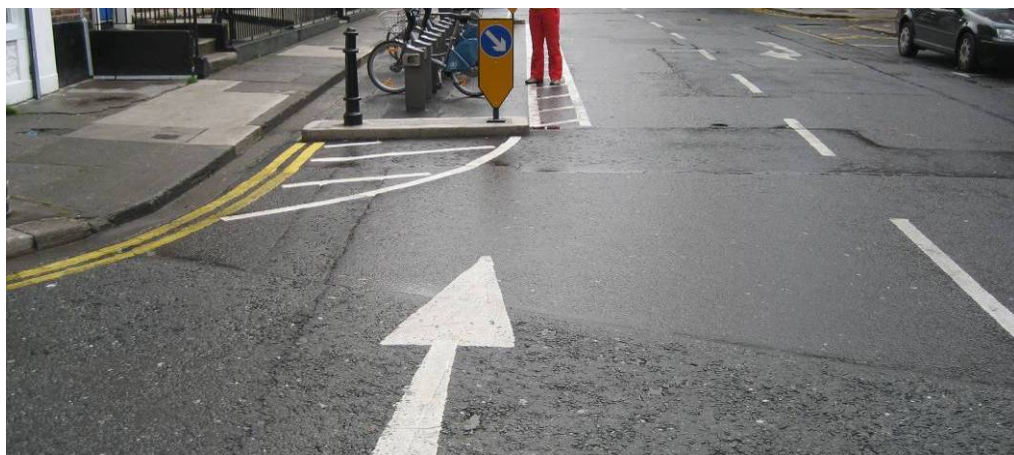
2.15 Site 15 (15B) Hardwicke Street

The existing 'arrow' road marking directs vehicles travelling north east along Hardwicke Street into the cycle station build out.

Remove or relocate the arrow marking.

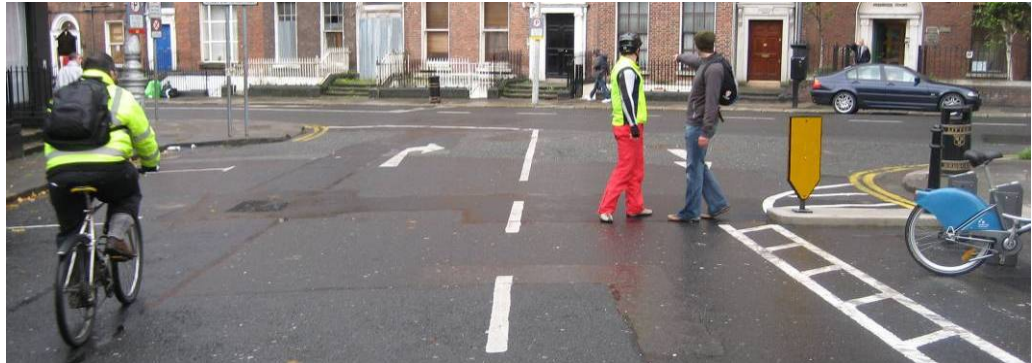
The cycle station has encroached into the existing in-bound running traffic lane, yet the lane markings have not been amended. Inbound motorists are forced into the oncoming lane resulting in possible conflicts with other motorists or cyclists.

The nearest public lighting column was not operational at the time of the night visit, leaving the station in total darkness. This could lead to personal security and safety issues at night time.

Reallocate the lane provision for opposing traffic streams to allow for the presence of the cycle station.

Ensure the public lighting column is repaired.

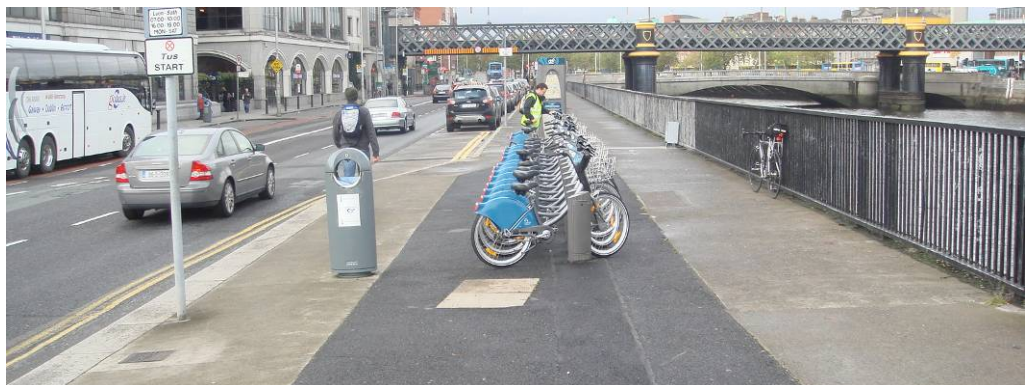
Site 16 (16A) Georges Quay

Service vehicles parked on Georges Quay are at risk of rear end shunting by traffic moving southbound over the Talbot Memorial Bridge turning right onto Georges Quay.

Ensure that service vehicles are not permitted to stop within 20 metres of the pedestrian crossing point on Georges Quay which immediately precedes the cycle station.

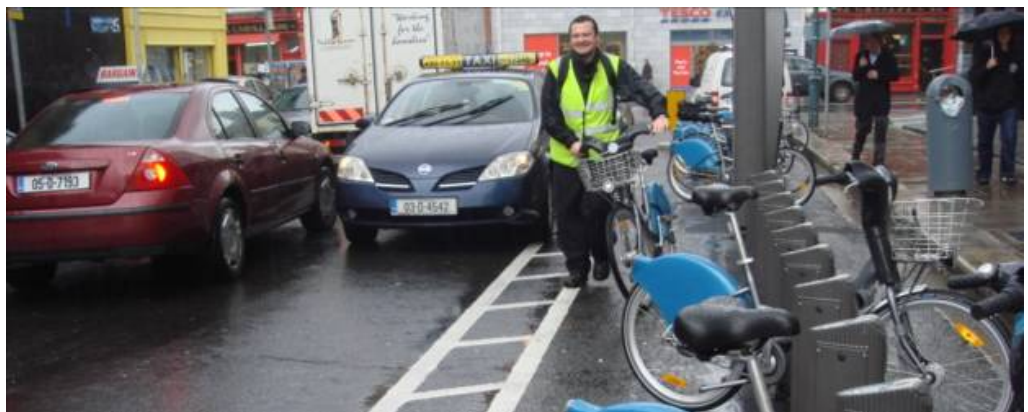
2.18 Site 18 (18) Grantham Street

The provision of the on street cycle station has resulted in a narrowing of the road carriageway to accommodate two-way traffic movements at the T-junction of Grantham Street / Camden Street Lower as well as cyclist movements to and from the cycle station.

The new lane configuration means traffic travelling from Camden Street Lower onto Grantham Street is forced to cross the central white traffic lane line with risk of conflict with traffic approaching the T-junction on Grantham Street or cyclists at the cycle station.

A service vehicle parked on Grantham Street directly adjacent to the station will cause a traffic obstruction.

Consideration should be given to removing a number of the on-street parking spaces along the northern side of Grantham Street opposite the cycle station in order to provide adequate space for two-way traffic movements and access to the cycle station.

Service vehicles should not be permitted to park on Grantham Street directly adjacent to the cycle station or in a position which limits visibility and traffic movement at the adjacent junction.

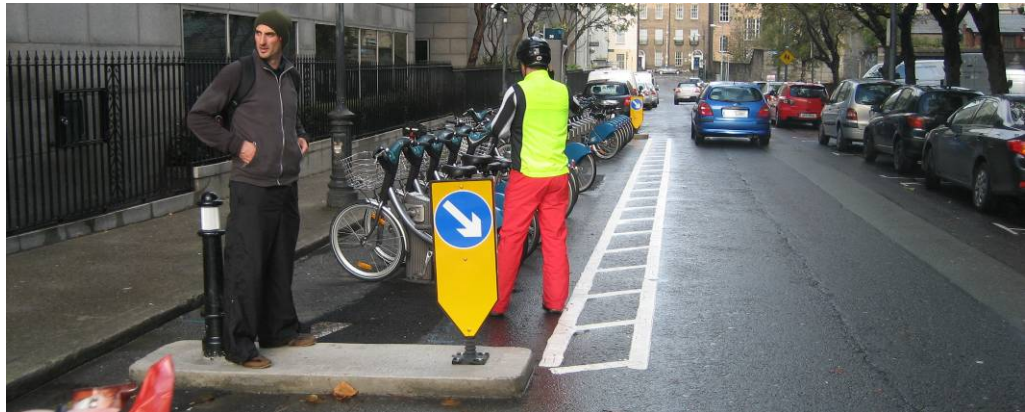
2.20 Site 20 (21) James Street East

Dublinbikes users may cycle the wrong direction into one-way traffic leaving the station.

Provide warning signage and a directional arrow marking on road to advise cyclists of the one-way regulation.

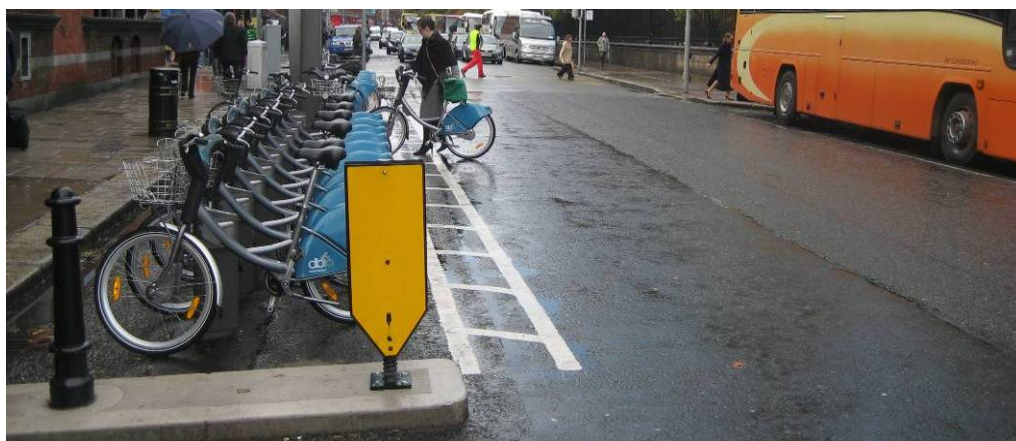
2.21 Site 21 (22A) Leinster Street South

The kerb build-out and 500mm buffer zone adjacent to the cycle station has resulted in a reduction of the width of the adjacent road carriageway. No carriageway lane markings are provided to delineate the two eastbound traffic lanes. There is a risk that eastbound vehicles, while vying for road space, may inadvertently strike a cyclist withdrawing a bicycle from the station.

Lane marking should be provided on the carriageway adjacent to the cycle station to promote good lane discipline.

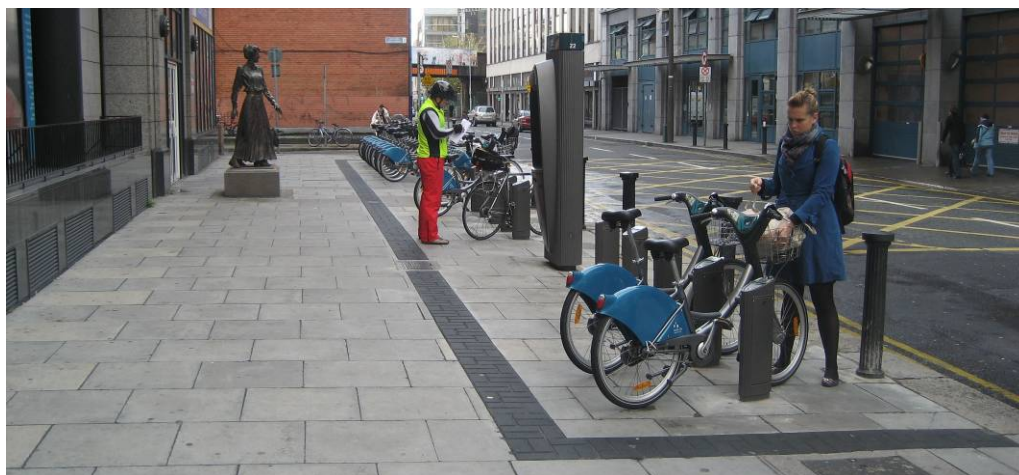
2.22 Site 22 (23C) Townsend Street

Service vehicles could obstruct vehicular access and egress from the Fire Station which is situated immediately opposite the proposed cycle station.

Ensure that service vehicles do not obstruct vehicular access and egress from the Fire Station. In this regard, service vehicles should not be permitted to stop within the yellow box junction in front of the Fire Station doors.

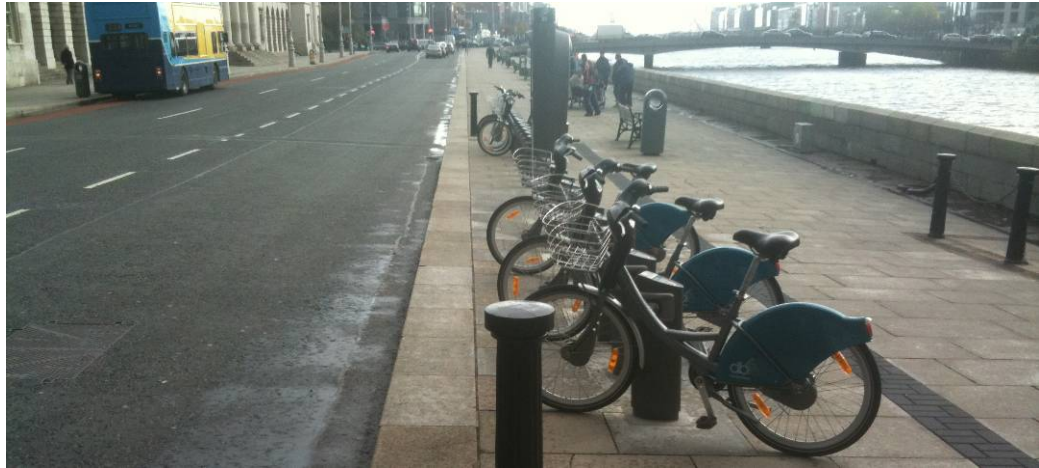
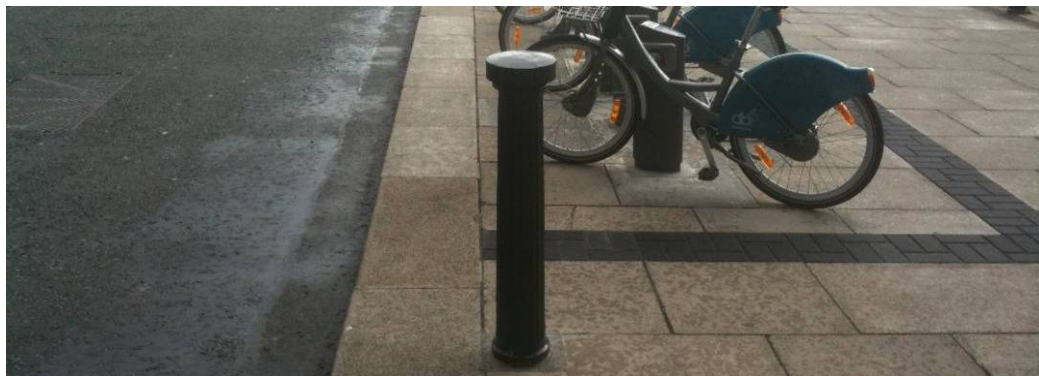
2.23 Site 23 (23D) Custom House Quay

The traffic bollards are difficult to identify, particularly for partially sighted road users and in low light and night time conditions.

The night time site visit noted that the cycle station was dimly lit due to the proximity of the station to the overhead DART rail line and the position of existing public lighting on the opposite side of Custom House Quay. Poor public lighting in this location could lead to personal security and safety issues at night time as well as exacerbating the problem identified previously.

There is a risk that a service vehicle parked on Custom House Quay between Butt Bridge and the cycle station will impede driver visibility to the station placing cyclists at risk of conflict with vehicular traffic.

Mount/fit reflective material on the bollards to provide a high level of visual contrast with their immediate surroundings. This will serve to highlight the bollards presence to cyclists and visually impaired road users.

Carry out a public lighting assessment at the station and provide additional public lighting if deemed necessary.

Service vehicles should not park adjacent to the kerb line on Custom House Quay between Butt Bridge and the cycle station. Service vehicles should park east of the cycle station to provide clear visibility to cyclists at the station.

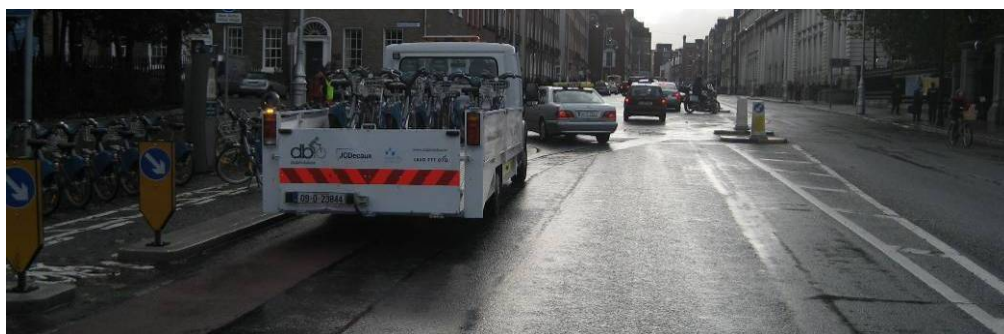
2.26 Site 26 (26) Merrion Square West

Service vehicles parked adjacent to the cycle station limit inter-visibility between southbound traffic and pedestrians waiting to cross Merrion Square West at the refuge island provided. This could result in conflict between vehicles and vulnerable road users.

Ensure that service vehicles do not park in a position which obstructs visibility to pedestrian crossing points.

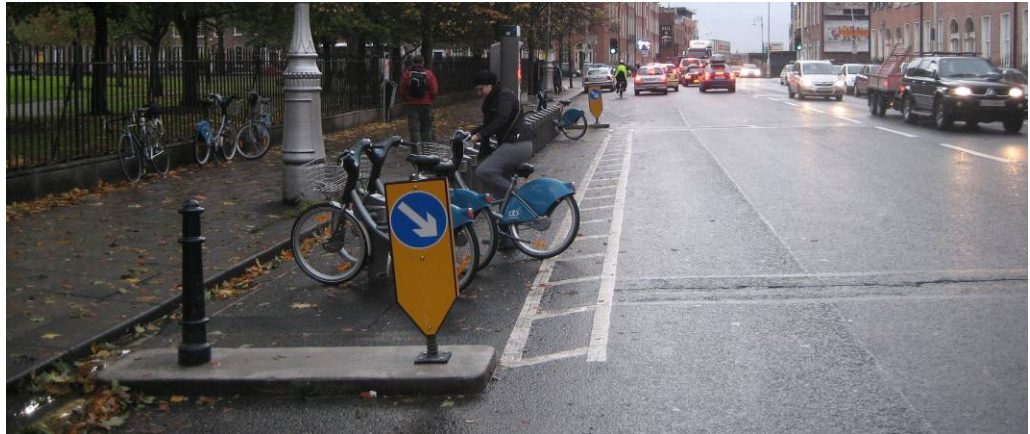
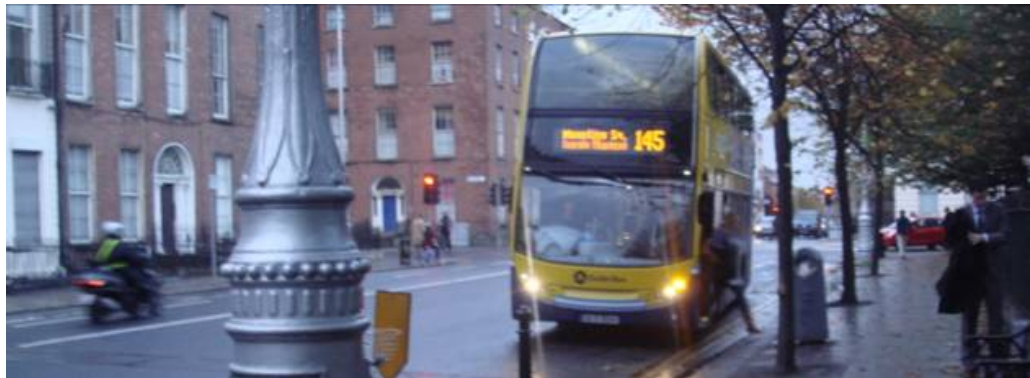
Site 28 (28A) Mountjoy Square West

The 145 Bus service was observed to turn right from Gardiner Place onto Mountjoy Square West and was unable to stop within the new bus stop markings due to their proximity to the junction.

The Bus Stop pole and sign was not erected at the time of the site visit.

Adjust the position of the bus stop to permit bus access as intended.

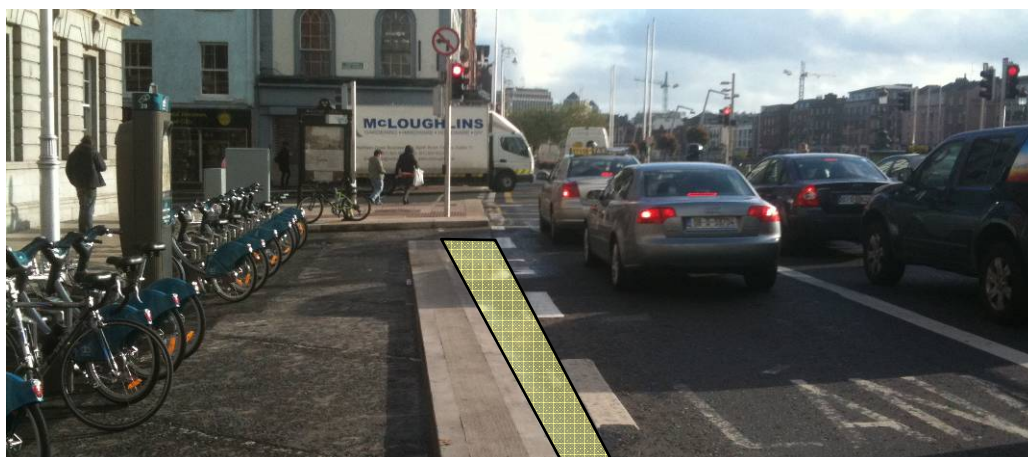
Site 29 (29) Ormond Quay Upper

The traffic island separating the cycle station from the bus lane and general traffic on the Quays has been constructed in line with the adjacent kerb line with the result that the island is skewed at an angle in relation to the adjacent traffic stream. This leaves the leading edge of the pedestrian crossing build-out exposed to vehicle strike and could also lead to a conflict between emerging cyclists or pedestrians and vehicles.

The traffic island should be in-filled/extended (see yellow shading) in line with the edge of the adjacent bus lane.

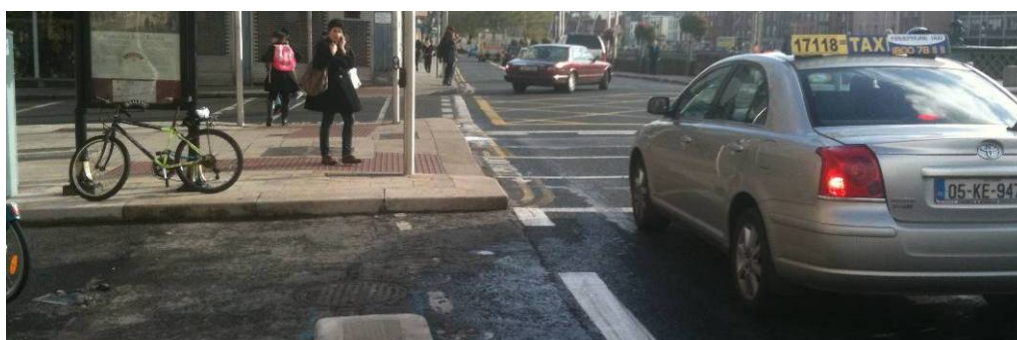
After cyclists leave the cycle station and rejoin the carriageway, there is little room before the traffic signals for cyclists to cross over to the offside lane to negotiate the right turn across Grattan Bridge.

Provide an advance stop line which will allow cyclists to enter the carriageway during the red stage of the signal phasing when traffic is stopped.

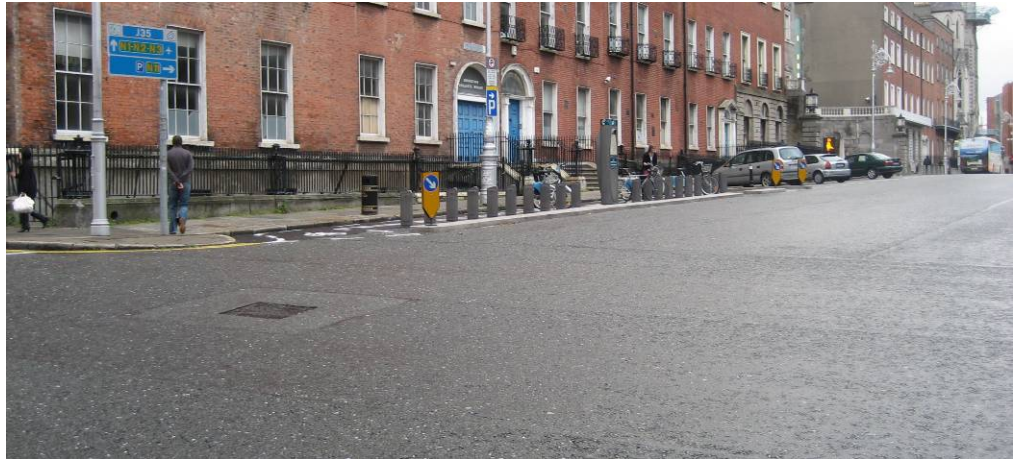
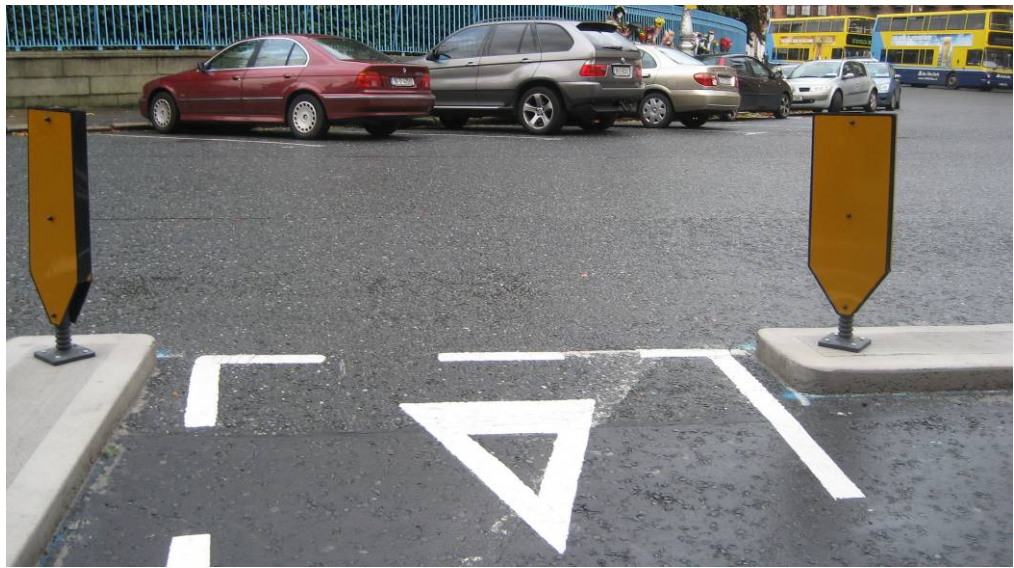
Site 30 (30A) Parnell Square North

Parnell Square North and Parnell Square West operate as a one-way system. Cyclists, particularly those who are new to the locale and are not familiar with the one-way system may inadvertently cycle against the flow of traffic resulting in conflict with vehicles.

Additional signage or road markings aimed at informing cyclists should be provided to direct cyclists in relation to the one-way system at this location.

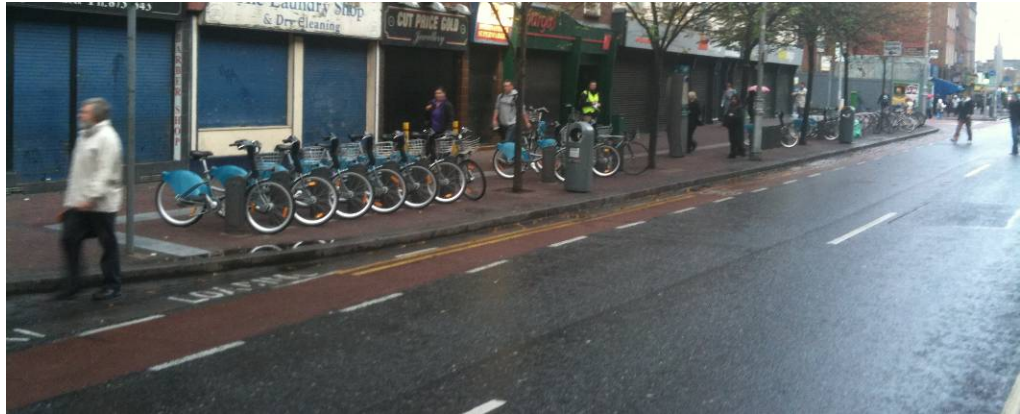
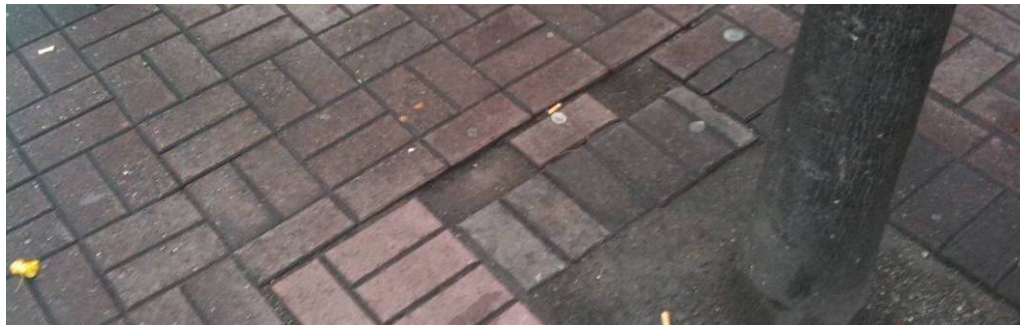
2.31 Site 31 (31) Parnell Street

The site visit noted a number of uneven, loose, and missing block pavers within the cycle station footpath forming trip hazards for cycle station users.

Remove all potential trip hazards.

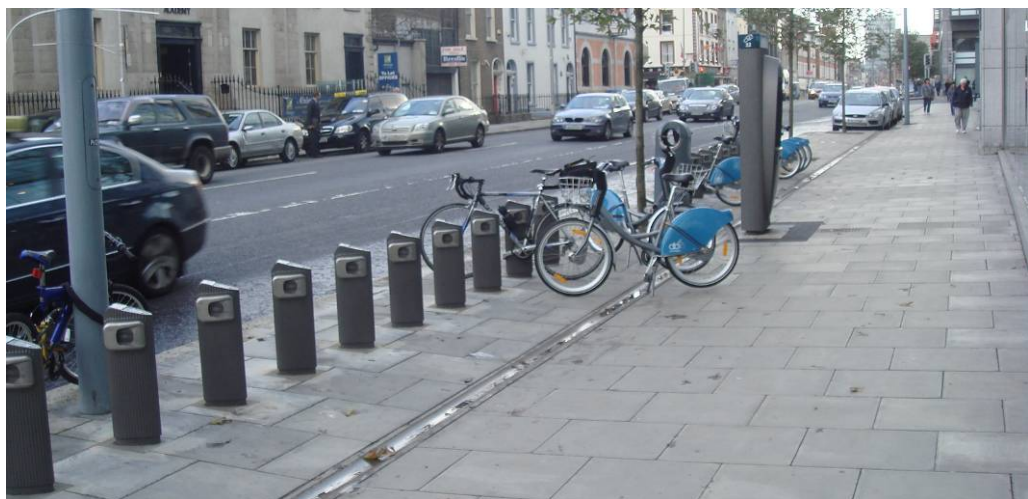
2.32 Site 32 (32) Pearse Street**2.32.1 Problem**

It was noted during the night time visit that the site was well lit, however this was largely due to light spill from the adjacent Trinity College buildings. It was also noted during the site visit that existing public lighting lamp heads were either missing or not yet installed in the vicinity of the cycle station. For continuity reasons, the illumination of cycle stations should not be dependent on private sources. Poor lighting could lead to personal security and safety issues at night time.

Ensure public lighting is provided to illuminate the proposed cycle station at night time.

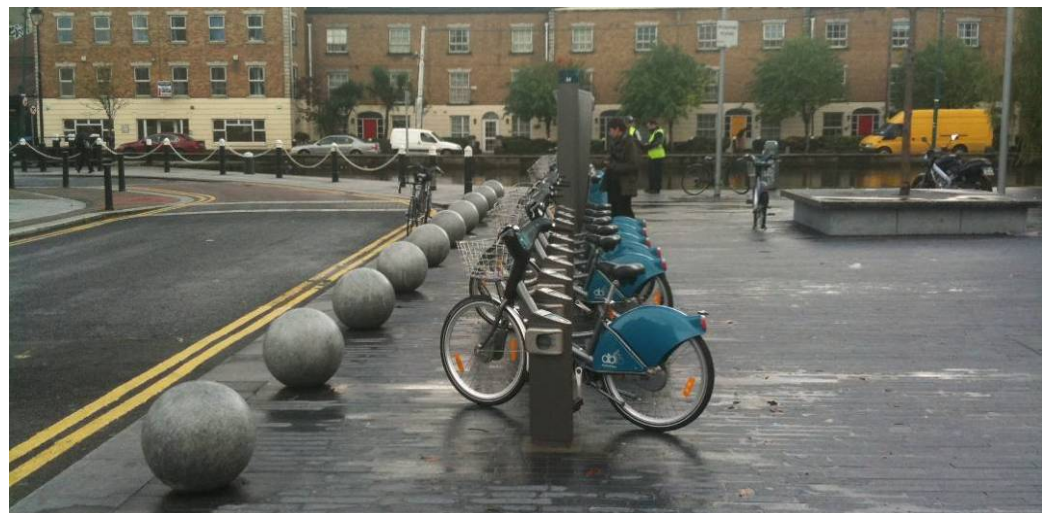
Site 34 (34) Portobello Harbour

There is an absence of contrasting delineation around the cycle station within the public plaza to distinguish the station from the plaza area. This could cause difficulty for partially sighted pedestrians, particularly when the station is depleted of bicycles.

The cycle station should be clearly delineated from the public plaza by employing the use of colour contrasting materials.

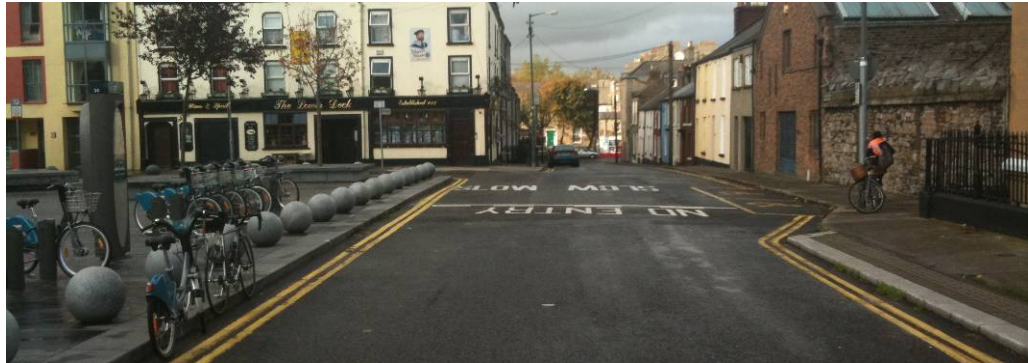
Richmond Row looking north

There is a contradiction in the road markings placed on Richmond Row adjacent to the cycle station. There are 'NO ENTRY' markings prescribed on the road carriageway in the southbound direction towards the canal indicating that Richmond Row is one way in the northbound direction whilst there are 'YIELD' markings placed in the northbound traffic lane outside Portobello College directing traffic to yield to traffic travelling from the north.

This contradiction will cause confusion for cyclists and motorists alike with resulting risk of conflict.

Road markings and the intention with respect to traffic movements on Richmond Row in the vicinity of the cycle station should be amended and clarified on site.

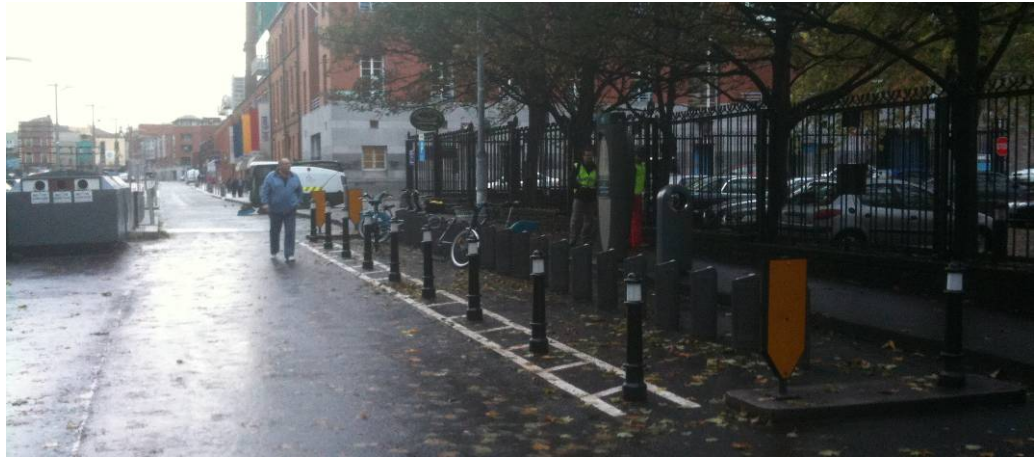
Site 35 (35C) Smithfield

The cycle station, in particular the station bourne, was observed to be dimly lit at night time. Poor public lighting in this location could lead to personal security and safety issues at night time.

Carry out a public lighting assessment at the station and consider the provision of additional public lighting at the station if deemed necessary.

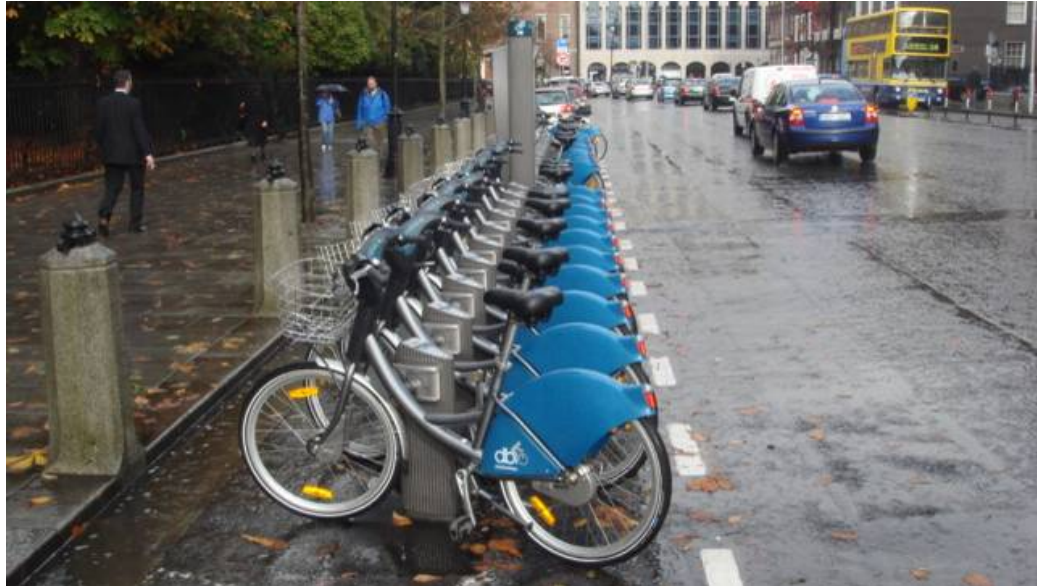
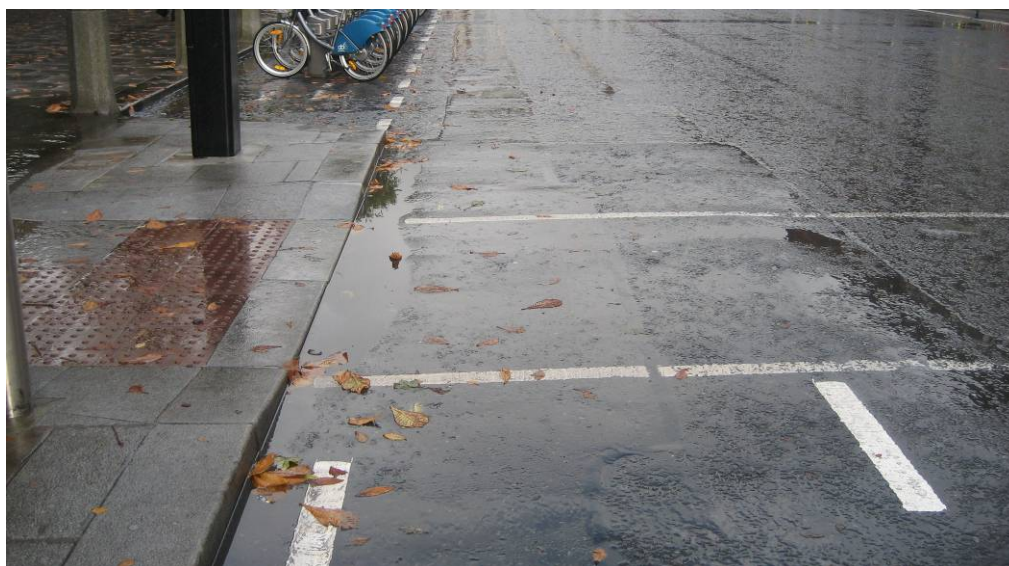
2.36 Site 36 (36) – St. Stephens Green East

The existing cycle lane markings, which serve to provide a buffer between the proposed cycle station and the adjacent vehicular traffic stream, end abruptly upstream of the cycle station. Drivers may not be alerted to the facilities location.

Service vehicles parked upstream from the cycle station could block visibility to the adjacent pedestrian crossing.

During and immediately after rainfall, water was observed to pond in the vicinity of the pedestrian crossing point (see image associated with 2.36.1). This could cause inconvenience and pose a risk to vulnerable road users, particularly in the event that the standing water freezes.

Replace the cycle lane markings adjacent to the cycle station or provide a buffer zone using line markings.

Ensure that service vehicles are not permitted to stop in such a position which blocks the pedestrian crossing or limits forward visibility to the pedestrian crossing point and/or the crossings traffic signals.

Adjust the channel levels to mitigate against the risk of standing water.

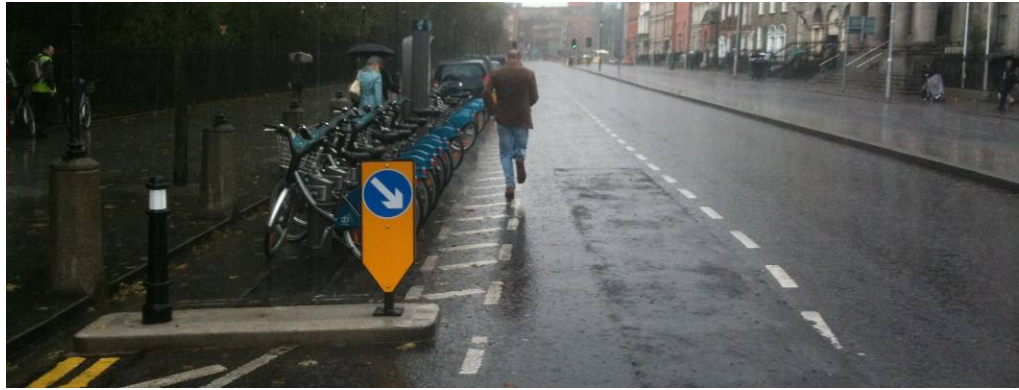
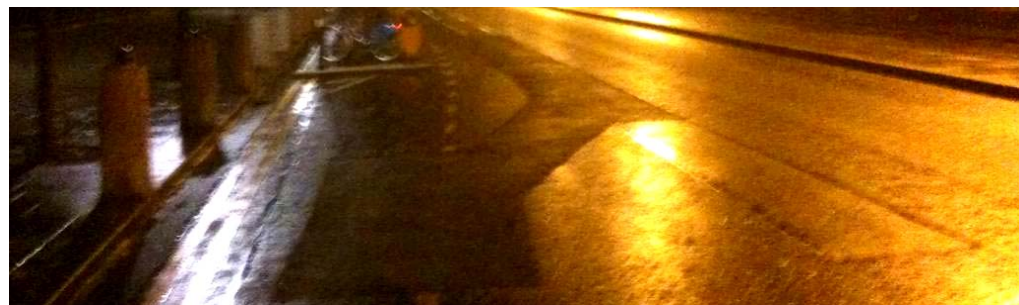
Site 37 (37) St. Stephens Green South

Recent road works have compromised the adjacent cycle lane markings. The reinstatement works are poor, being left proud of the surrounding pavement surface which could result in loss of control type accidents for cyclists.

Improve the surface finish of the reinstatement works and replace cycle lane markings and logo at this location.

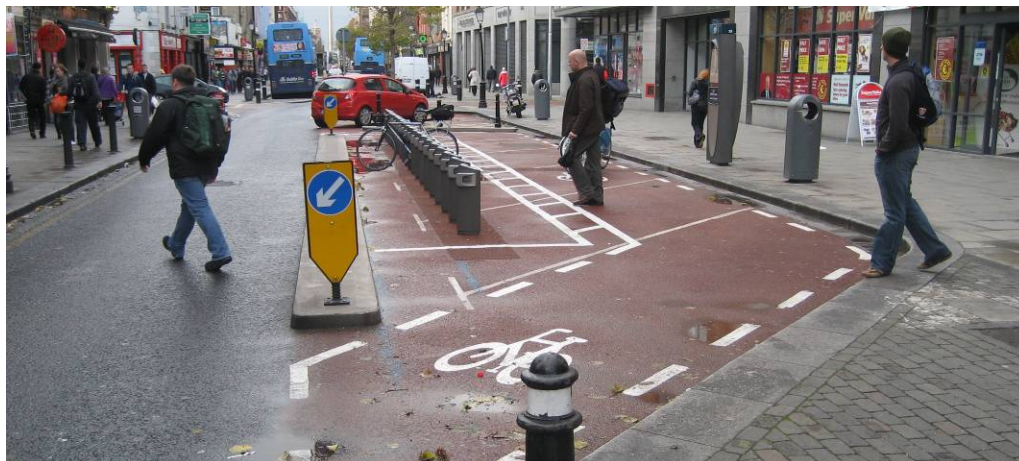
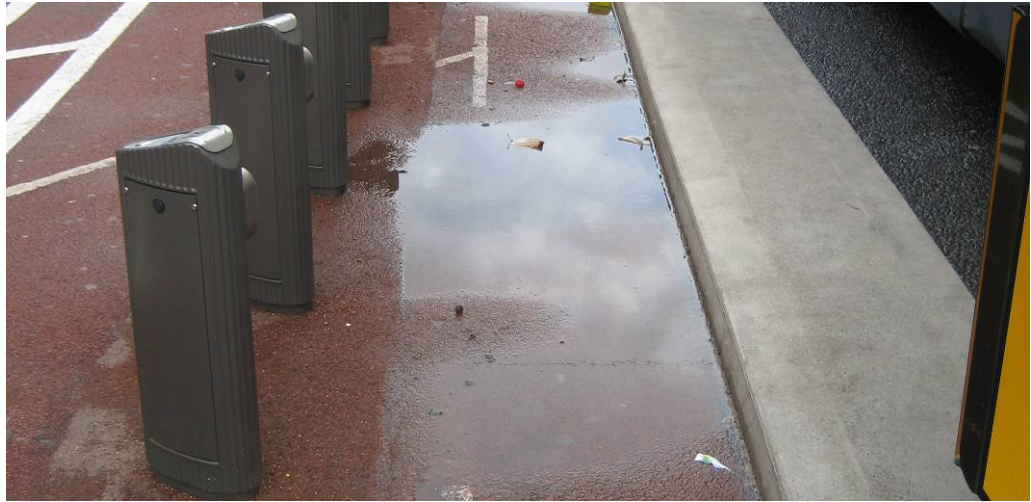
Site 38 (38) Talbot Street

Standing water was observed in proximity to the new buffer island which could cause inconvenience to station users and pose a slip hazard in freezing temperatures.

Carry out remedial drainage works to eliminate the occurrence of standing water.
