***Cycling Infrastructure Audit***

***Westport Smarter Travel – Cycling Audit Report***

**November 2013**

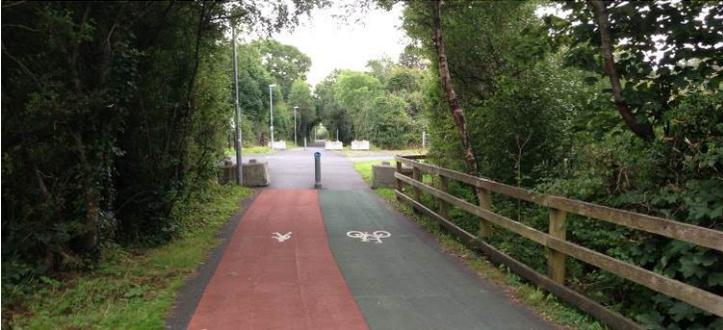
<p>Granary house crossing – no warning signage.</p>	<p>Warning signage should be erected on the greenway on both approaches to the crossing to warn fast moving cyclists in particular of the potential danger. A warning sign should also be provided on the access road approach in the southern direction.</p>

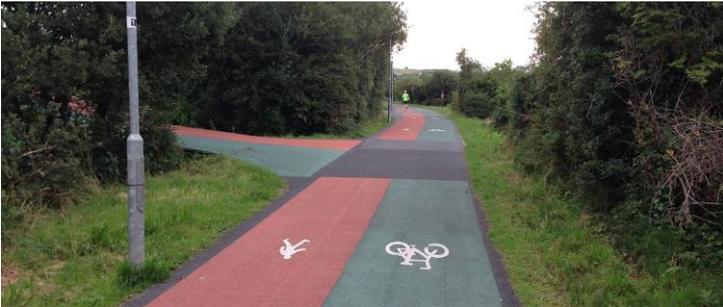
<p>No directional or information signage at spur link junction.</p>

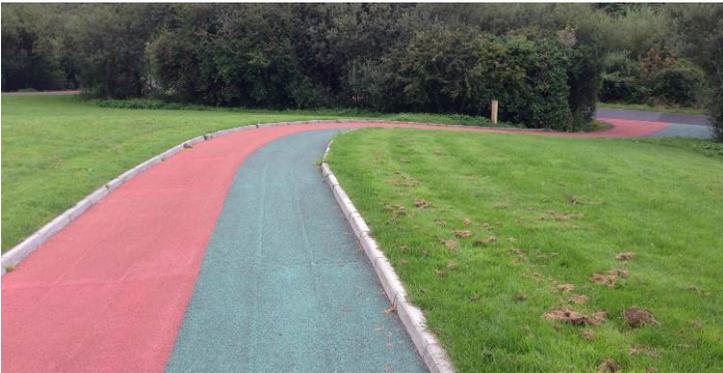
<p>Steep gradient on approach to greenway.</p>	<p>Direction and information signage should be erected at the junction with the estate link displaying the estate name and the direction to the town centre and the Quay as well as distances to each.</p> <p>The site visit noted that there is another greenway link to Ocean View/Woodpark estates in close proximity to the link to Harbour Village. The possibility of combining the two links into one link from the greenway in order to reduce the steepness of the link approaches to the greenway should be considered.</p>

<p>If it is not possible to realign the two links then guard-railing (at junction) and/or fencing (opposite T-junction) should be provided at the spur link junction with the greenway to prevent cyclists overshooting on approach and coming into conflict.</p>

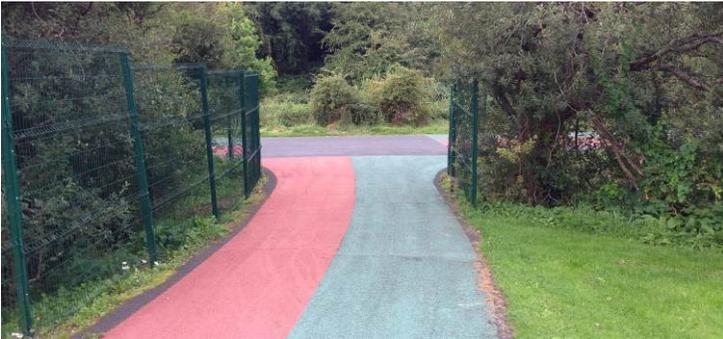
Ref.	Location	Problem	Photograph	Remedial Measure
4.	Greenway Link to Ocean View/ Woodpark estates	<p>1. There is no direction or information signage at the junction with the greenway stating that the link is to a residential estate.</p> <p>2. The gradient linking the estate to the greenway is very steep.</p> <p>3. The greenway link pavement surface is cracking on the eastern side of Ocean View and there is settling/slipping of the embankment.</p> <p>4. The blue shared pedestrian/cycle symbol is missing from a number of bollards within the estates.</p> <p>5. The drop kerb linking Ocean View with the greenway link has not been adequately provided and is higher than recommended guidelines.</p>

<p>No direction or information signage at link junction. Steep approach gradient.</p>

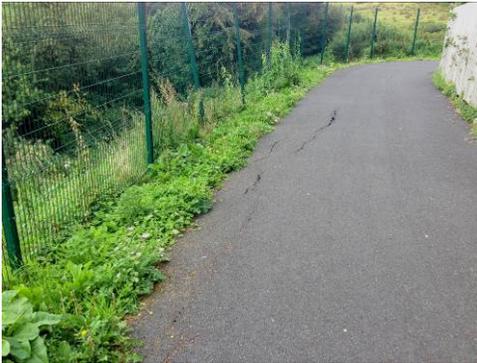
<p>Pavement cracking &amp; embankment slipping at Ocean View</p>

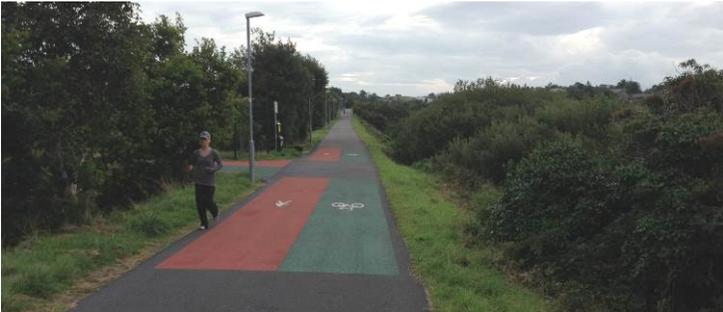
<p>No direction or information signage at link junction. Exposed embankment opposite junction.</p>

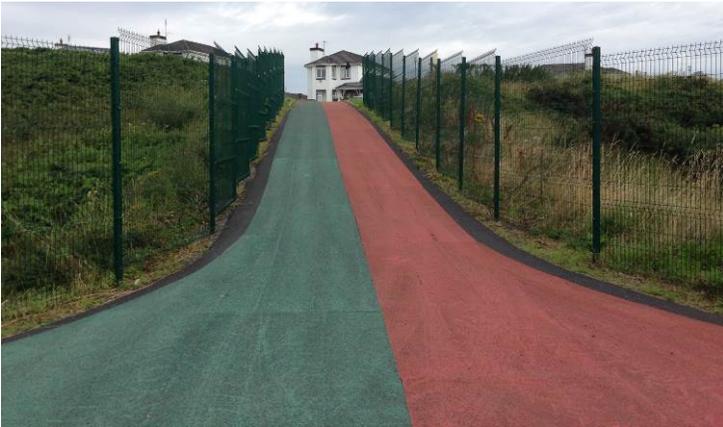
<p>Steep gradient on approach to greenway from Westlands.</p>	<p>Direction and information signage should be erected at the junction with the estate link displaying the estate name and the direction to the town centre and the Quay as well as distances to each.</p> <p>Guard-railing (at junction) and/or fencing (opposite T-junction) should be provided at the link junction with the greenway to prevent cyclists overshooting on approach and coming into conflict.</p>

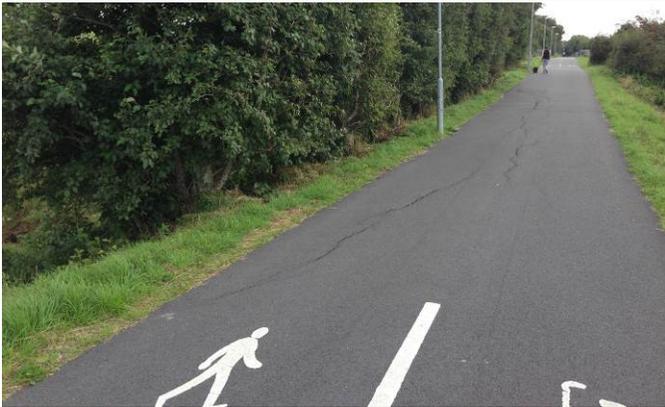
Ref.	Location	Problem	Photograph	Remedial Measure
6.	Between Westlands and skate park	The greenway pavement surface is cracking and settling over a distance of approx. 20 – 30m along the northern edge.

<p data-bbox="741 655 1128 683">Pavement cracking and settling.</p>	Investigations into the cause of the pavement cracking should be carried out immediately and repairs undertaken.

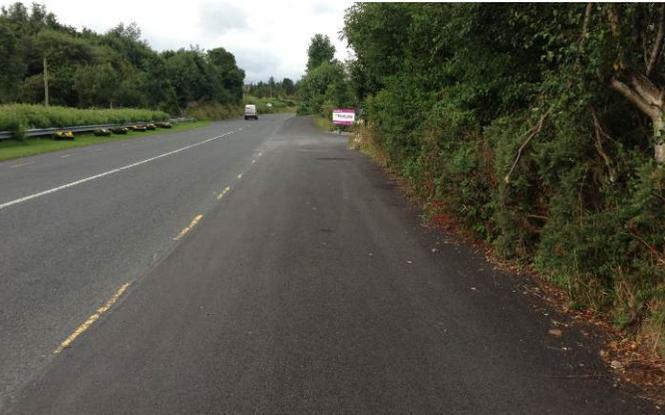
7.	R335 – link between R335 greenway to Croagh Patrick and Westport town greenway	<p data-bbox="439 727 703 1010">There is a short section of missing greenway path between the link to the Westport town greenway and the existing greenway to Croagh Patrick along the R335.</p> <p data-bbox="439 1042 703 1294">Connectivity between the R335 greenway and the Westport town greenway is not well defined by markings, signage or other greenway infrastructure.</p>

<p data-bbox="741 1150 1458 1238">Section of missing greenway infrastructure along the R335 linking the Westport town greenway with the existing R335 greenway to Croagh Patrick/Killary.</p>	The hard shoulder space photographed should be formalised into a shared pedestrian and cycle greenway to link the existing R335 greenway seamlessly with the Westport town greenway. This could be achieved by a combination of signage, markings and physical infrastructure to separate the road carriageway from the greenway.

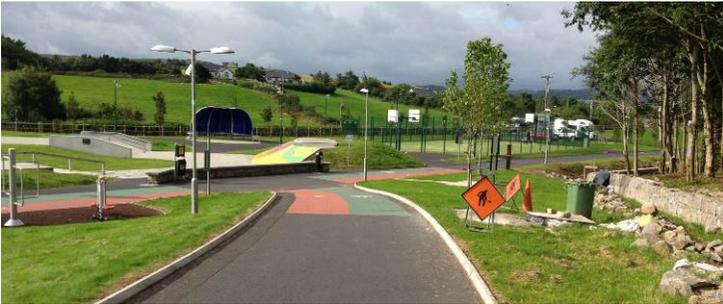
<p>No direction or information signage at link junction. Steep gradient on approach to greenway from Reek View.</p>	<p>Direction and information signage should be erected at the junction with the estate link displaying the estate name and the direction to the town centre and the Quay as well as distances to each.</p> <p>Guard-railing (at junction) and/or fencing (opposite T-junction) should be provided at the link junction with the greenway to prevent cyclists overshooting on approach and coming into conflict.</p>

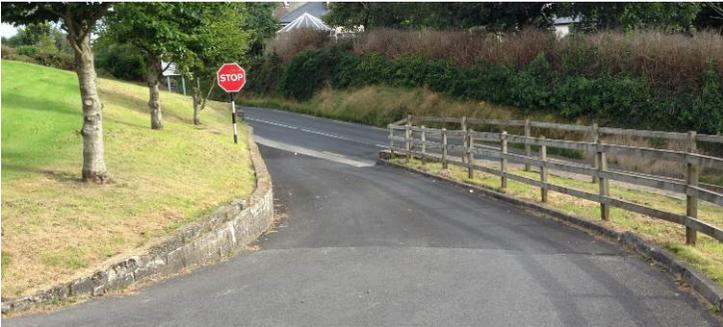
<p>No greenway direction or information signage at N59 junction. Steep gradient on approach to N59 from greenway with limited visibility.</p>	<p>Direction and information signage for the greenway should be erected at the junction with the N59.</p> <p>Guard-railing should be provided on the footpath at the junction with the greenway to prevent cyclists overshooting the narrow footpath on approach to the N59 and coming into conflict with pedestrians on the footpath or passing vehicles on the N59.</p>

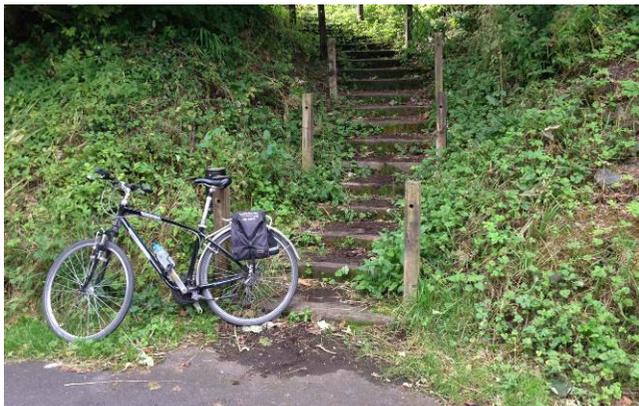
<p>No direction or information signage at steps. Layout of steps does not facilitate a cyclist.</p>	<p>Direction and information signage should be erected on the greenway providing information on where the steps connect to.</p> <p>A bicycle friendly 'groove' could be provided adjacent to the steps to aid a cyclist pushing a bike up/down the steps (example below).</p>

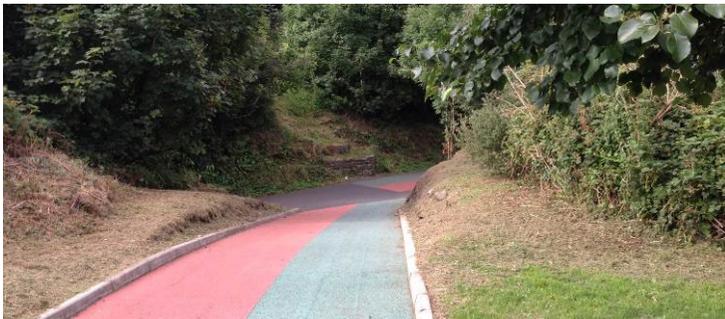
<p>No direction or information signage at link junction. Steep gradient on approach to greenway.</p>	<p>Direction and information signage should be erected at the junction with the estate link displaying the estate name and the direction to the town centre and the Quay as well as distances to each.</p> <p>Guard-railing (at junction) and/or fencing (opposite T-junction) should be provided at the link junction with the greenway to prevent cyclists overshooting on approach and coming into conflict.</p>

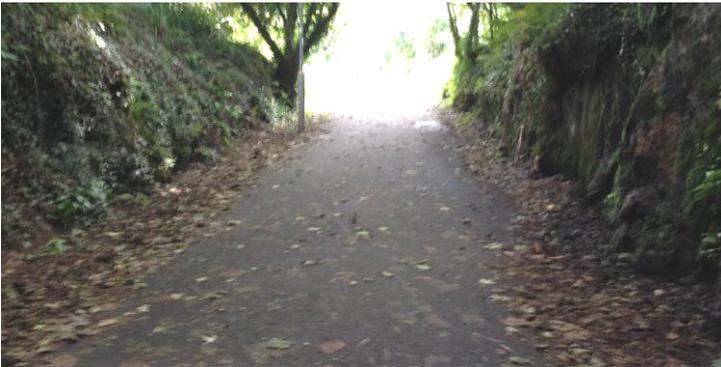
Ref.	Location	Problem	Photograph	Remedial Measure
12.	Rock cut section of greenway between The Elms and Railway Walk Apartment link ramp.	There is deterioration in the quality of the pavement surface. Debris from filter drains is scattered over the path and there is a large pothole exiting the rock cut section in the direction of Westport.

<p>Deterioration in quality of pavement surface.</p>	<p>Any surface repairs such as the pothole described should be undertaken.</p> <p>Any existing debris should be swept off the pavement and maintained free of debris at all times.</p>

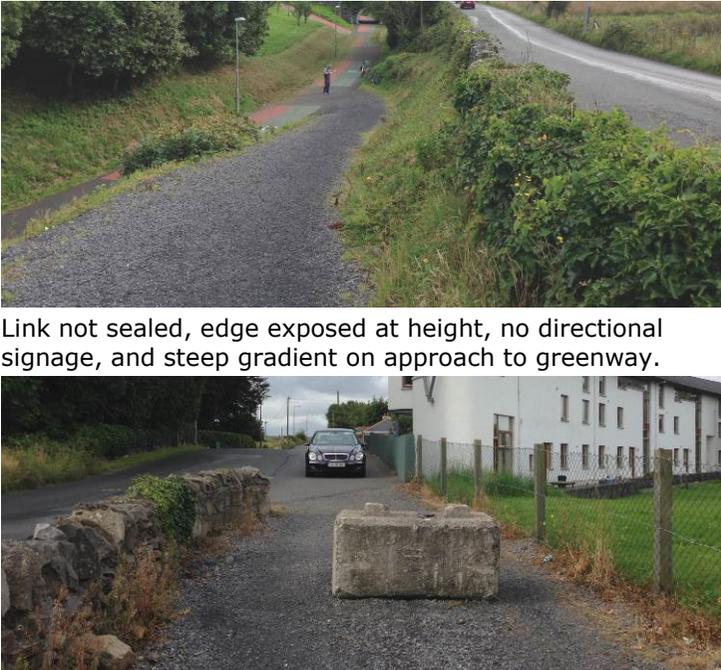
<p>Link not sealed, edge exposed at height, no directional signage, and steep gradient on approach to greenway.</p> <p>No continuation of ped/cycle facilities at top of ramp link.</p>	<p>Provide a fully paved surface treatment consistent with the rest of the scheme.</p> <p>Provide a fence and/or barrier along the edge of the exposed embankment.</p> <p>Direction and information signage should be erected at the junction with the ramp link.</p> <p>Guard-railing should be provided at the link junction with the greenway to prevent cyclists overshooting on the approach and coming into conflict.</p> <p>Provide continuous pedestrian/cyclist facilities at the top of the ramp link to connect with the closest receptors.</p>

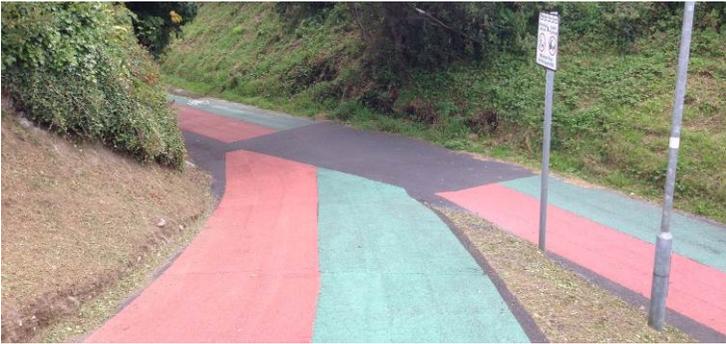
<p>Steep gradient and no signage.</p>

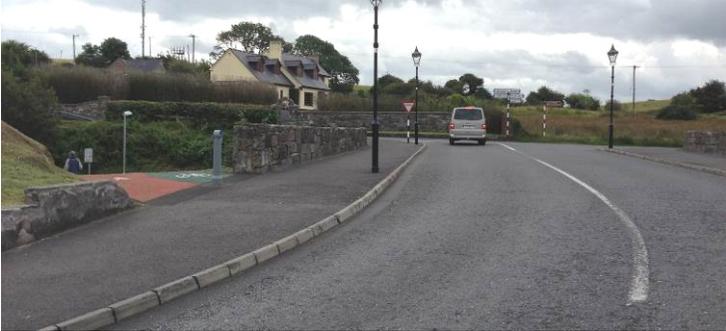
<p>High St – no continuation of facilities and no signage</p>

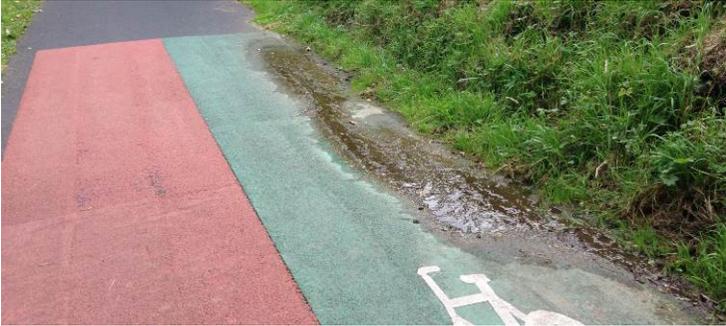
<p>Drainage problem – water ponding</p>	<p>Direction and information signage should be erected at the junctions with the greenway.</p> <p>Guard-railing should be provided at the link junctions with the greenway to prevent cyclists overshooting on approach and coming into conflict.</p> <p>Provide drop kerbs at a minimum and continuous cycle facilities if possible at the top of the ramp links on High Street. Erect direction or information signage on High Street at the greenway links.</p> <p>Carry out surfacing repairs to address drainage problem.</p> <p>Install lights within the 'tunnel' section at the underbridge.</p>

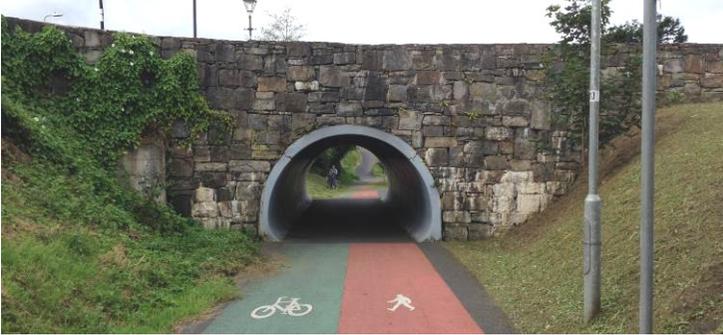
<p data-bbox="741 592 1317 619">Underbridge 'tunnel' section dark at night-time.</p>	
15.	Greenway link to Mountain View	A path has been worn along a short section of embankment between Monument View boundary wall and the greenway. There is a risk of a pedestrian or cyclist slipping and falling in the absence of formalised steps or a ramp.

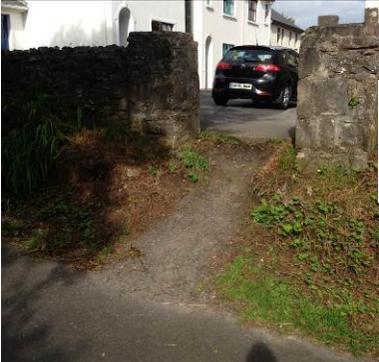
<p data-bbox="1153 726 1413 817">Path worn between greenway and Monument View</p>	Provide fully connected facilities between Monument View and the greenway i.e. formalised steps, ramp etc.

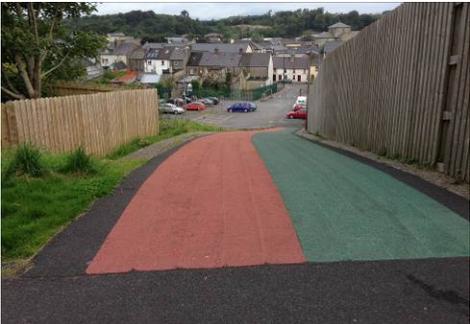
<p data-bbox="741 1380 1182 1407">Very steep gradient and no signage.</p>	<p>Direction and information signage should be erected on the greenway and also on Mill St.</p> <p>Hand-railing should be erected along the full length of the link ramp to aid pedestrians.</p> <p>Guard-railing should be considered at various locations along the link ramp to prevent cyclists from travelling at high speed. Signs advising cyclists to dismount their bicycles at the top of the link ramp should be considered.</p>

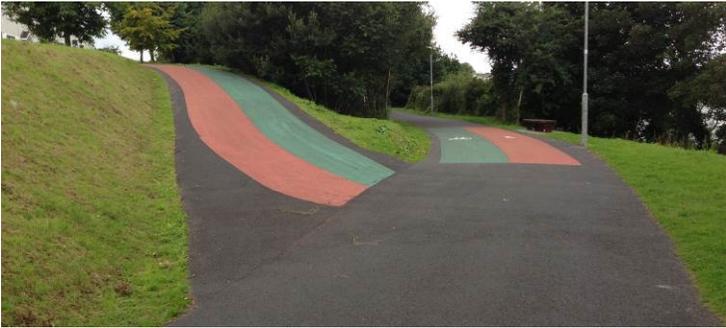
<p>Steep gradient and no signage.</p>

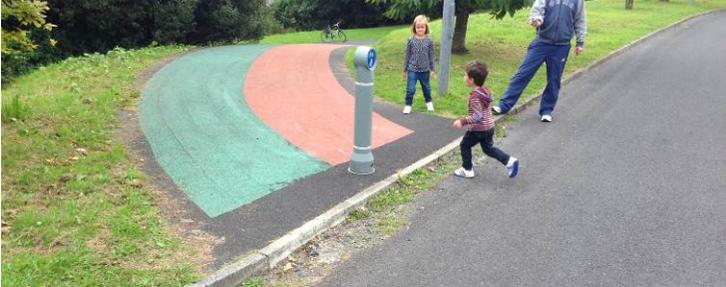
<p>No drop kerb provided</p>

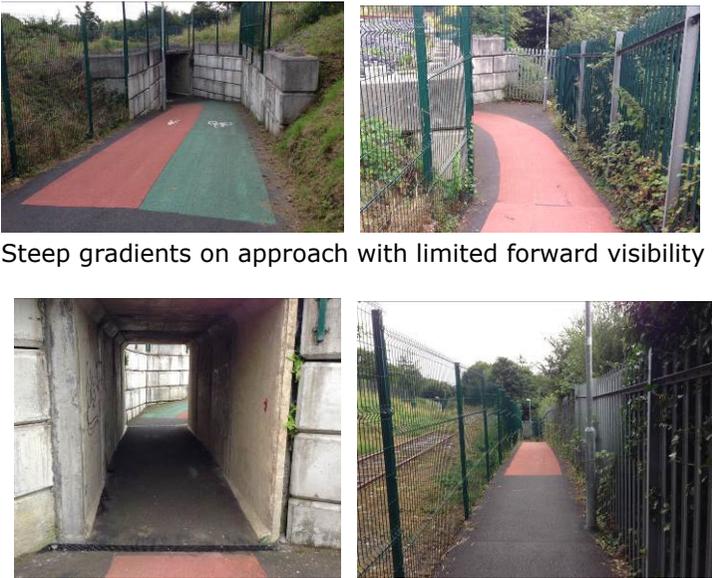
<p>Steep gradients on approach with limited forward visibility</p> <p>Narrow greenway width at bridge and on approach – no lighting within underbridge</p>	<p>Warning signage should be provided on both approaches to the underbridge informing approaching pedestrians and cyclists of the hazard ahead.</p> <p>Install lights within the 'tunnel' section at the underbridge.</p>

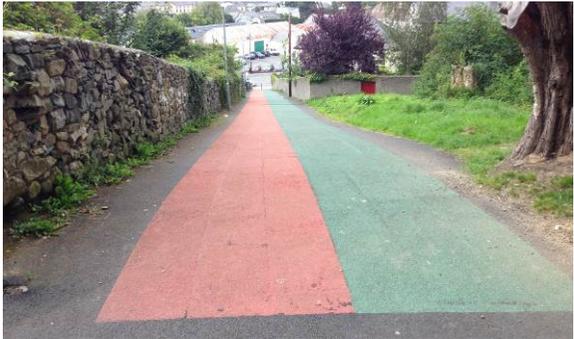
<p>Very steep gradient and no signage.</p>

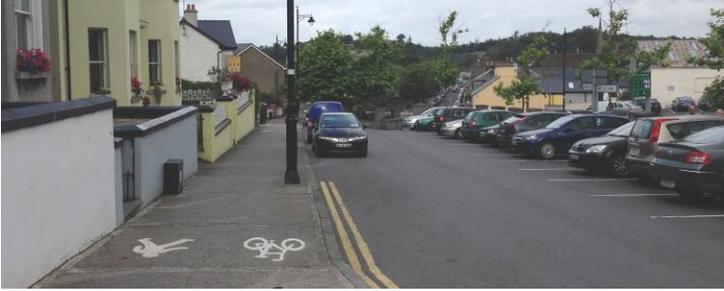
<p>Shared space on 'old' footpath. No signage to greenway</p>

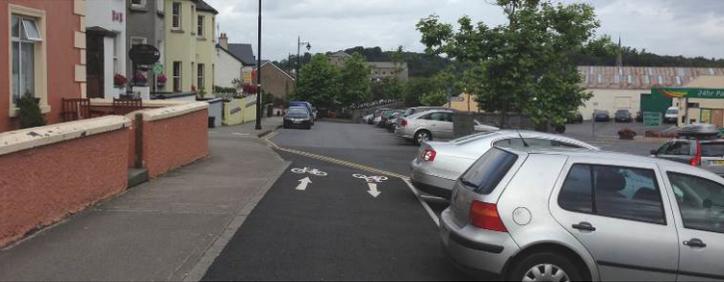
<p>New off road cycle track does not align with 'old' footpath. No signage to greenway</p>	<p>Direction and information signage should be erected within the car park to direct cyclists and pedestrians towards the greenway.</p> <p>Improved facilities for cyclists should be considered such as continuing the new section off road cycle track adjacent to the 'old' footpath to tie-in with the greenway link at the western end of the car park.</p>

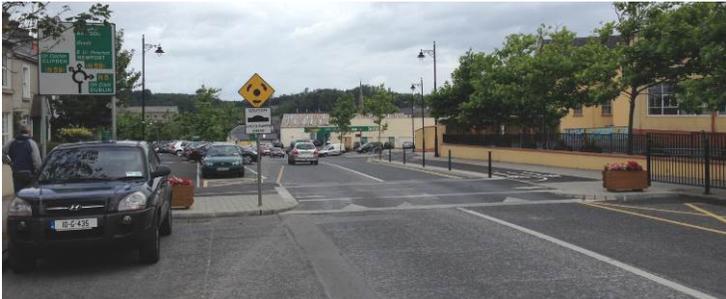
Ref.	Location	Problem	Photograph	Remedial Measure
2.	Altamount Street - shared pedestrian and cycle crossing	<p>1. It is not clear what form of control is intended or in operation at the crossing. There are no traffic signals or flashing beacons at the crossing to highlight the crossing to passing drivers. In addition, no warning signage of the crossing is erected on Altamount St and pedestrian crossing hazard warning markings have not been provided on Altamount St.</p> <p>2. There is no direction signage to the town greenways at the crossing point.</p>

<p>Absence of traffic control and markings and signage at the crossing. No signage to greenways</p>	<p>Driver awareness of the crossing should be highlighted by advance warning signage, road markings and traffic signal control if deemed necessary.</p> <p>Greenway signage should be erected in the vicinity of the crossing.</p>

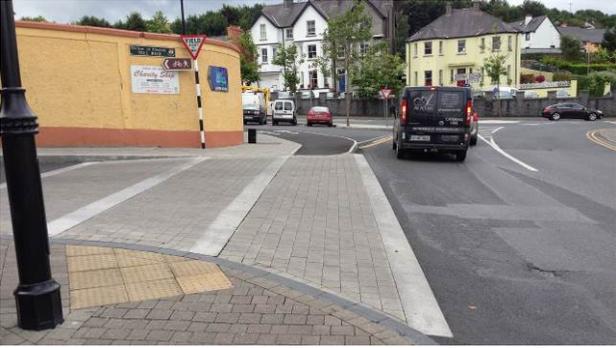
<p data-bbox="757 628 1361 655">Very poor greenway signage at Mill Road junction</p>

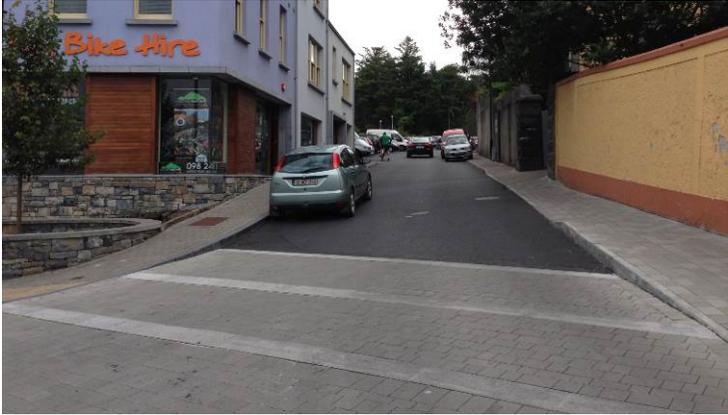
<p data-bbox="757 1098 1435 1157">No road markings or signage to direct cyclists along Mill Road to greenway.</p>	<p data-bbox="1509 678 2092 802">Cycle logos should be marked on Mill Road to raise driver awareness of cyclists using the road to access the greenway and the Clew bay bike hire shop.</p> <p data-bbox="1509 831 2092 922">Greenway way-finding signage should be erected along Mill Road to direct pedestrians and cyclists to the greenway.</p>

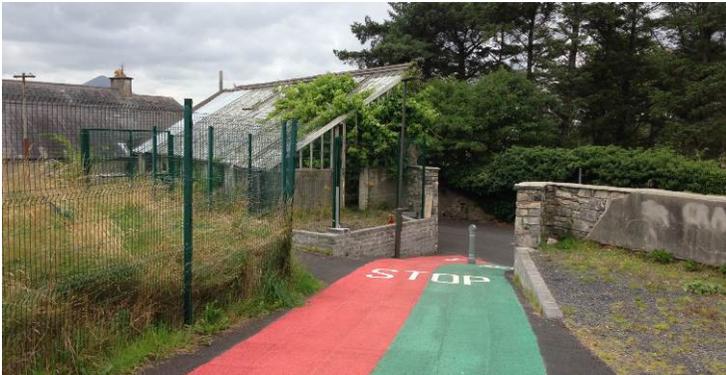
<p>Steep gradient on approach to Mill Road. No signage – direction or information or warning.</p>	<p>Direction, information and warning signage should be erected at the greenway junction to address the signage issues raised. A STOP sign should be considered in conjunction with the STOP markings to remind cyclists to stop.</p> <p>Guard-railing should be considered at the start/end of the greenway to prevent cyclists from travelling at high speed through the junction.</p>

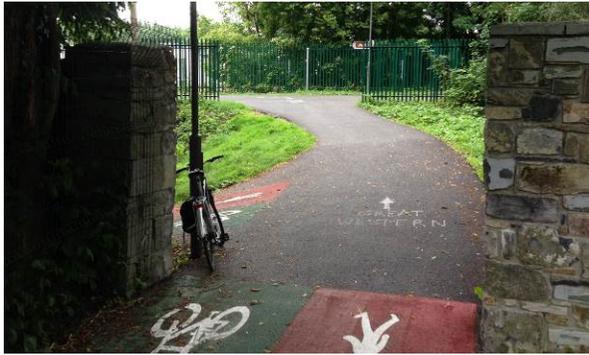
<p>No direction signage at junction. Confusing layout.</p>

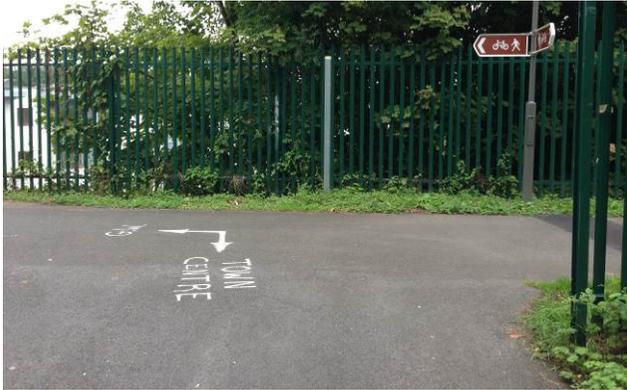
<p>Very poor directional signage at T-junction on greenway.</p>	<p>Improved greenway directional signage should be erected at the location described.</p>

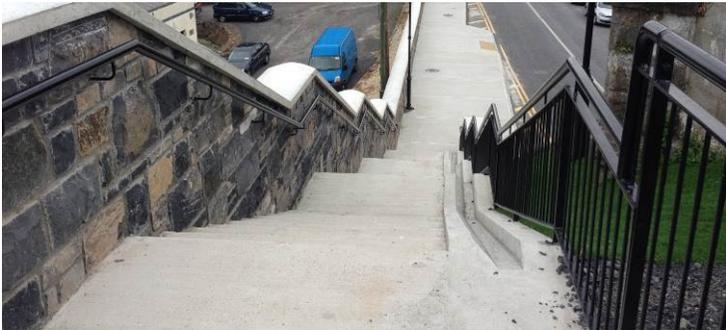
<p>Concrete channel next to steps – function not clear</p>	<p>The functionality of the cycle channel would benefit from the erection of a small sign at both ends explaining its use.</p> <p>Provide greenway direction signage in the vicinity of the steps.</p>

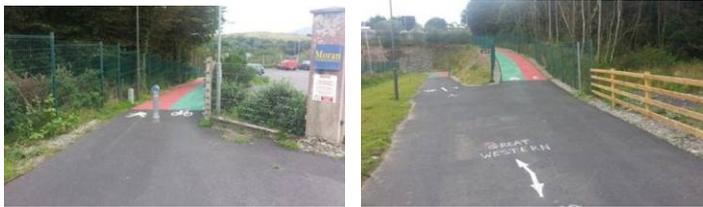
<p>Lack of adequate greenway signage. Steep gradient on link</p>	<p>Directional greenway signage should be provided at both ends of the link.</p> <p>Guard-railing should be considered at the start/end of the greenway link to prevent cyclists from travelling at high speed onto the main greenway.</p>

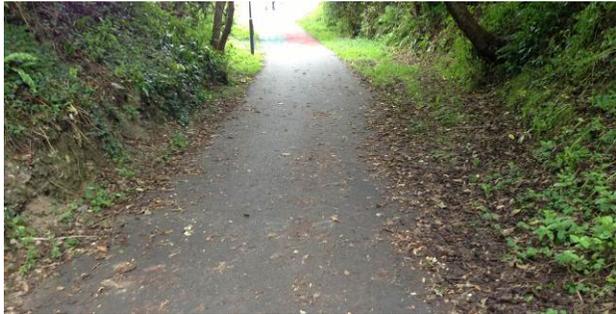
6.	Greenway – between Rice College and Knockranny link	<p>There is a deterioration in the quality of the pavement surface. Debris from side embankments is scattered over the surface narrowing the available cross section.</p>

<p>Debris strewn over path narrowing available width</p>	<p>Measures should be implemented to keep the greenway path free of verge and side embankment encroachment. The Greenway path should be swept and maintained free of debris at regular intervals.</p>

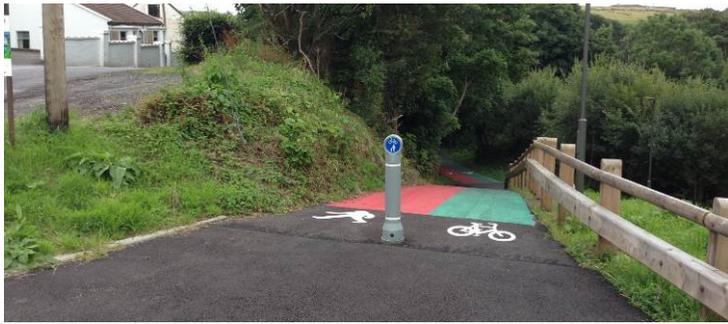
<p>Very steep approach gradient from Knockranny. No greenway signage.</p>	<p>Direction and information signage should be erected on the greenway at the link junction and also on the road at Knockranny to direct users to the greenway.</p> <p>Hand-railing should be erected along the full length of the link ramp to aid pedestrians.</p> <p>Guard-railing should be considered at various locations along the greenway link ramp to prevent cyclists from travelling at high speed.</p>

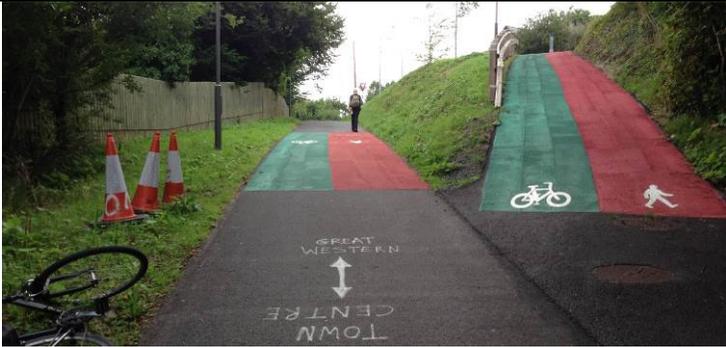
<p data-bbox="759 624 1413 651">Steep gradient. No greenway signage at link junction.</p>	
8.	Section through Knockranny greenway under-bridge	The section of greenway between the N5 and the spur link to Knockranny is characterised by steep gradients associated with the underbridge and poor resulting forward visibility. Cyclists can pick up high speeds and there is a risk of conflict with other cyclists and pedestrians as a result.

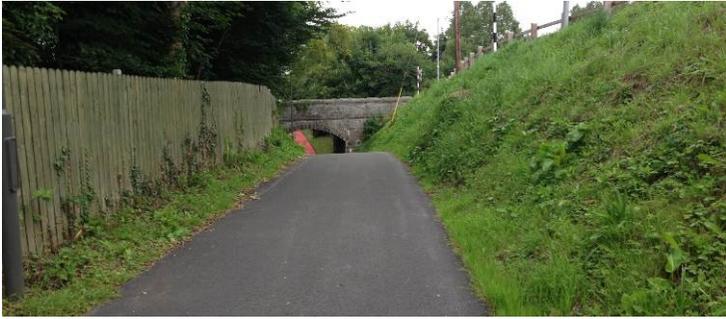
<p data-bbox="759 1007 1379 1058">Steep gradients and poor forward visibility through underbridge</p>	Guard-railing should be considered at various locations on both sides of the underbridge to prevent cyclists from travelling at high speed.  Consideration should also be given to erecting signs to warn cyclists to slow down and beware of other greenway users.

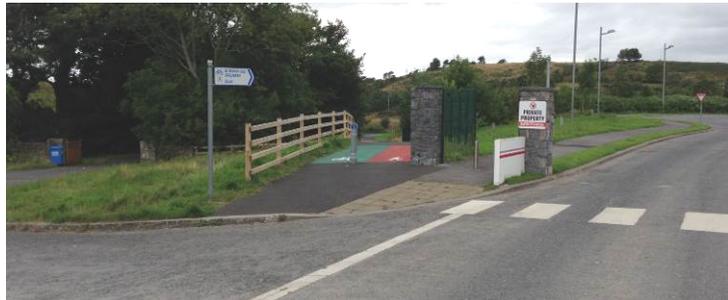
<p>Poor level of signage</p>	Signage should be erected at this location which addresses the problems raised and is consistent with greenway signage used elsewhere throughout Westport.

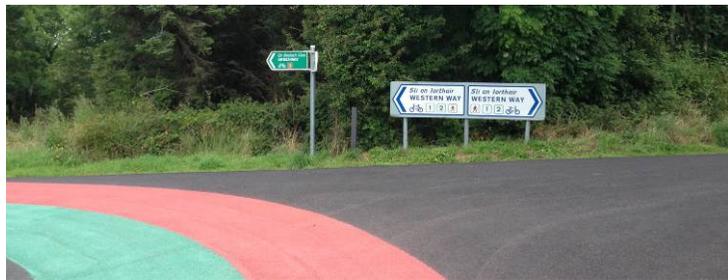
<p>Inconsistent and confusing signage</p>

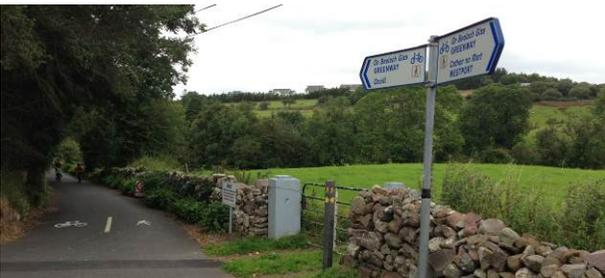
<p data-bbox="741 528 1435 555">No signage to direct greenway users to Westport via N59</p>	Erect signage showing the nearest direction to Westport Town Centre via the N59 junction.

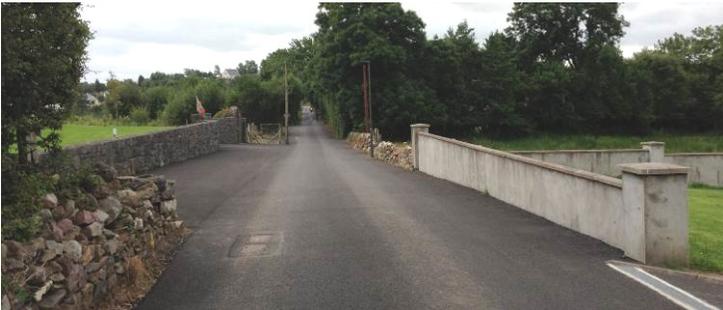
5.	Ashwood Place	The section of route along Ashwood place between the N59 and the Great Western Greenway is poorly signed and lacking in road markings indicating that the road is shared with pedestrians and cyclists. A high number of cyclists including young children were noted on the road during the site visit accessing the Great Western Greenway.

<p data-bbox="741 903 1435 930">Poor signage and no road markings indicating shared use</p>	More shared use road signs and pedestrian and cycle logo markings should be provided along the road to reinforce the shared use message to all road users and create a road environment which is more pedestrian and cycle friendly.

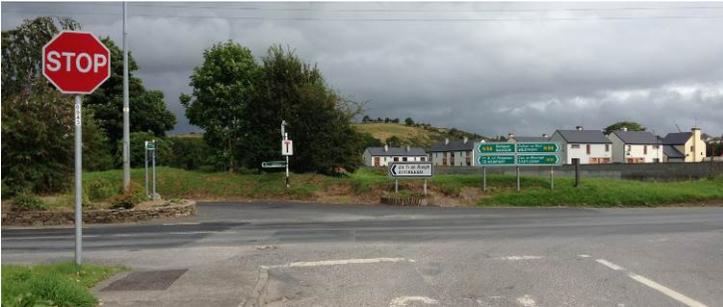
Ref.	Location	Problem	Photograph	Remedial Measure
6.	N59 Junction – Start/End of Greenway section	<p>The site visit noted this junction to be the most heavily used by pedestrians and cyclists during the site visit and also the most hazardous in terms of road safety within the scheme extents for the following reasons:</p> <ol style="list-style-type: none"> <li>1. There is no facility for pedestrians and cyclists to cross the very busy N59 National Road in terms of a controlled or uncontrolled crossing.</li> <li>2. Pedestrians and cyclists are forced to cross the road unaided with very poor visibility onto the N59 when crossing the road from Attireesh to the Golfcourse Road.</li> <li>3. Vehicles travelling past the junction on the N59 did so at high speed, in particular travelling out of town.</li> </ol>

<p>1. No facility for pedestrians and cyclists to cross N59</p>

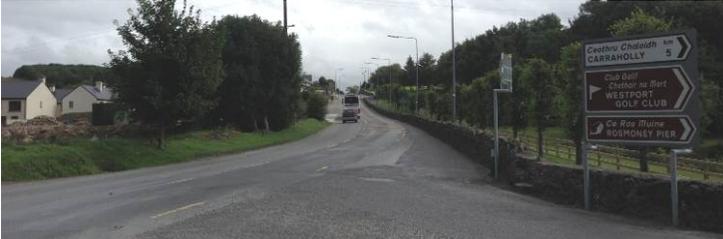
<p>3. Vehicles travel fast past junction downhill from Westport</p>	<ol style="list-style-type: none"> <li>1. Provide a controlled toucan crossing of the N59 at this location, similar to the new crossing provided on the N5, to link the greenway on the Attireesh side of the N59 with the Golfcourse road.</li> <li>2. Improve emerging visibility from Attireesh onto the N59 by relocating signage and trimming trees and hedgerows back.</li> <li>3. Consideration should be given to some form of traffic calming on the N59 exiting Westport in the direction of the junction to slow traffic.</li> <li>4. Signage should be rationalised at the junction to address the problems raised. Greenway signage should be erected which is clear and consistent with greenway signage provided elsewhere.</li> </ol>

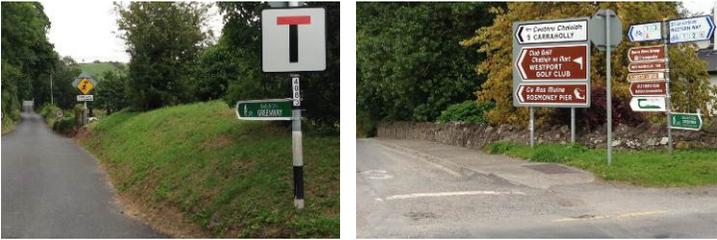
Ref.	Location	Problem	Photograph	Remedial Measure
		<p>4. Signage at the junction is particularly poor. There are no warning signs for cyclists on approach to the junction from either side indicating that they are approaching a major road junction. The Golfcourse road side of the junction is cluttered with numerous signs and direction signage to the town greenway and Great Western Greenway is poor and inconsistent with signage used elsewhere.</p> <p>Pedestrians and cyclists were observed to cross the N59 with confusion, lack of confidence and showing signs of nervousness. The current arrangement at this junction needs to be urgently addressed.</p>

<p>4. Poor greenway signage and signage clutter</p>

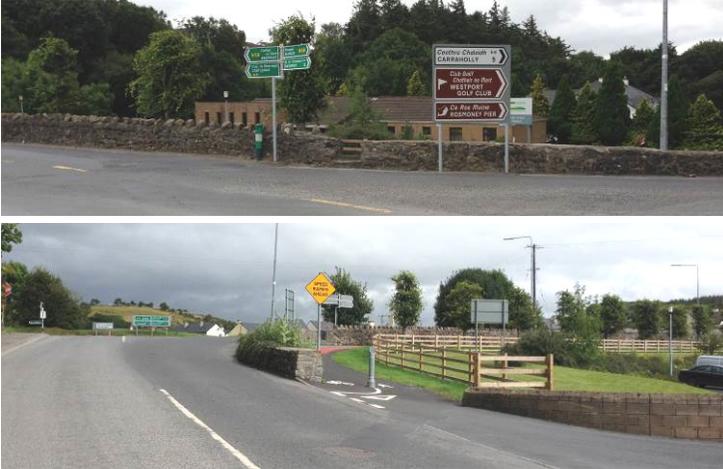
Ref.	Location	Problem	Photograph	Remedial Measure
1.	Start/end of greenway at the Golfcourse Road/N59 junction at Teagasc	The greenway is hidden behind a high boundary wall along the N59 with no signage on the N59 to indicate its presence. The site visit noted numerous cyclists continuing on the N59 in the direction of Westport having exited from the Great Western Greenway at Attireesh.

<p data-bbox="741 778 1402 836">No signage or advertising of greenway which is hidden behind high boundary wall on the N59</p>	Greenway signage should be erected to highlight the presence of the greenway. Such signage should include directional signage to Westport town centre, Westport House and the Great Western Greenway and also be cognisant of any improvements to the junction with the N59.

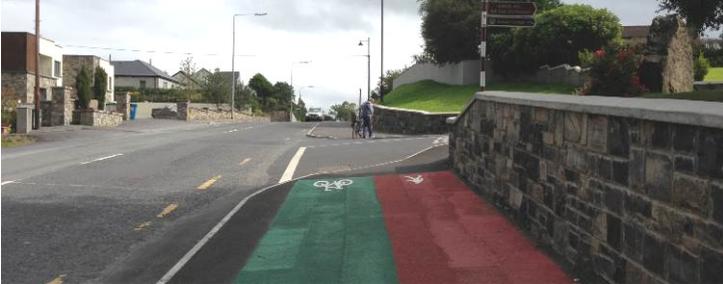
<p data-bbox="741 1177 1424 1235">Nothing to tell cyclists how they should continue journey towards town centre at Kings Hill</p>	Signage should be erected at this location instructing cyclists to either dismount or continue their journey across the estate road on the wide footpath.  Alternatively, the green and red greenway markings could be provided on the other side of the junction on the footpath to continue the facility off road.

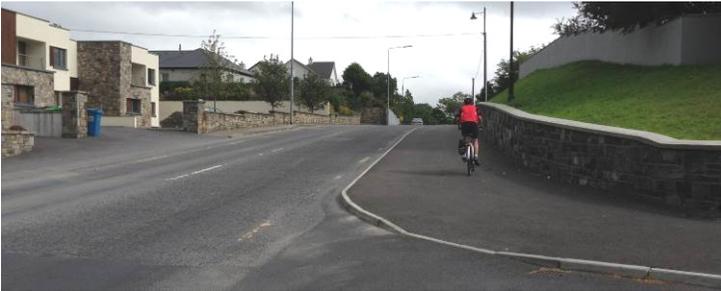
<p>No markings or signage to indicate path is for shared pedestrian and cycle use or for pedestrian use only.</p>

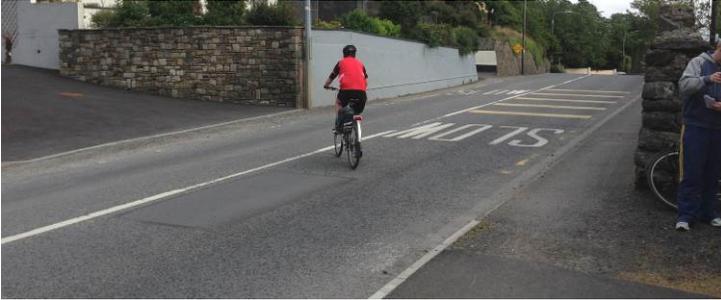
<p>No facilities at end of improved section of path for cyclists to mount or dismount the path safely.</p>	<p>Markings should be provided on the path for cyclists indicating that the path is for shared use if that is what is intended for the path. Otherwise, cyclists should be informed to join the carriageway at the Kings Hill junction and cross safely at this location.</p> <p>The start/end of the improved section of path should be provided with facilities such as a drop kerb to allow a cyclist to mount or dismount the path onto the N59 road carriageway safely. Warning signage should also be considered on the N59 warning motorists of the risk of cyclists crossing the road at this location.</p>

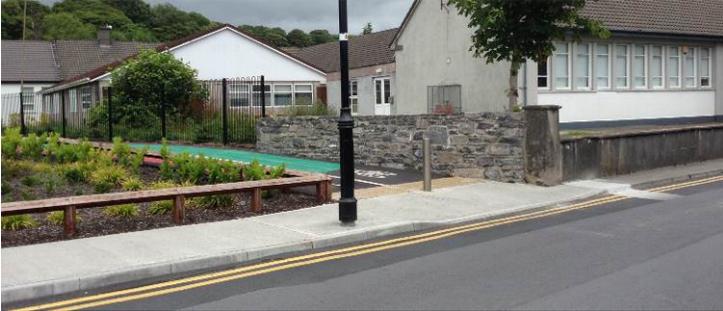
<p>Lack of information and direction signage on New Road to the greenway and to Westport town centre.</p>	<p>Signage should be erected at the start/end of the greenway and also along New Road to guide greenway users. The signage should be clear and concise and consistent with greenway signage used elsewhere.</p>

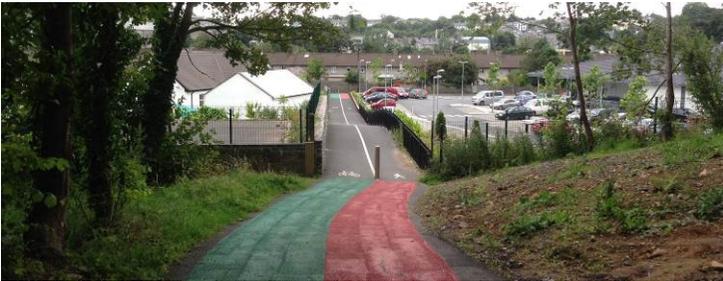
<p>Steep gradient in southern direction alongside Lidl</p>	<p>Guard-railing should be provided on the footpath on New Road to prevent cyclists overshooting onto New Road from the greenway at speed.</p> <p>Consideration should also be given to some form of guard-railing or hand-railing along the greenway next to Lidl to act as a barrier with which to slow cyclists in the southern direction and to aid pedestrians walking up the hill against the gradient.</p>

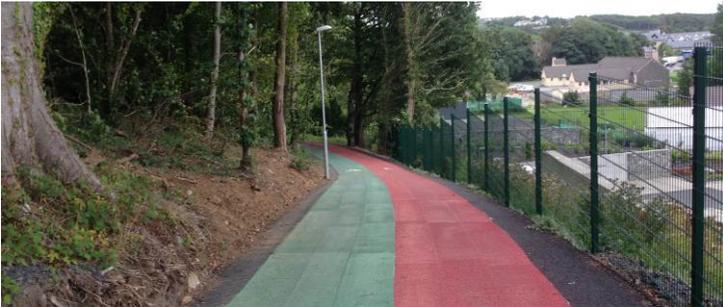
<p>Steep gradient in southern direction towards Lidl.</p>

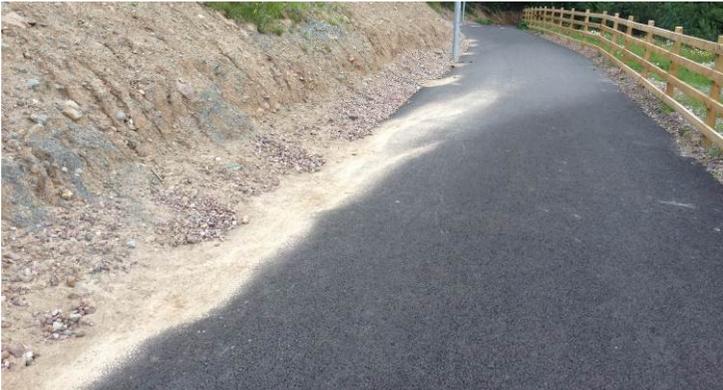
<p>Embankment slope migrating onto greenway</p>	<p>Consideration should be given to some form of guard-railing or hand-railing along the greenway to act as a barrier with which to slow cyclists and to aid pedestrians walking up the hill against the gradient.</p> <p>The greenway should be kept clear of any debris and the embankment closely monitored for any evidence of further movement and slipping. Remedial works should be carried out on the embankment if required.</p>

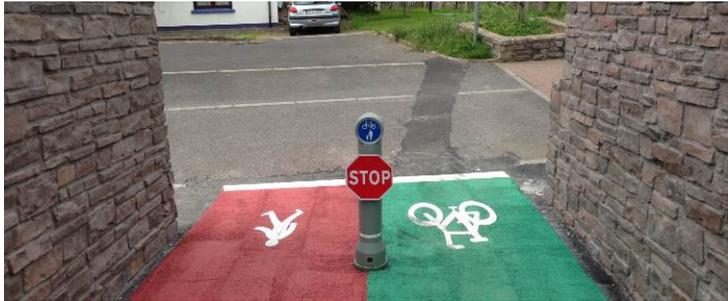
<p>No emerging visibility at junction</p>

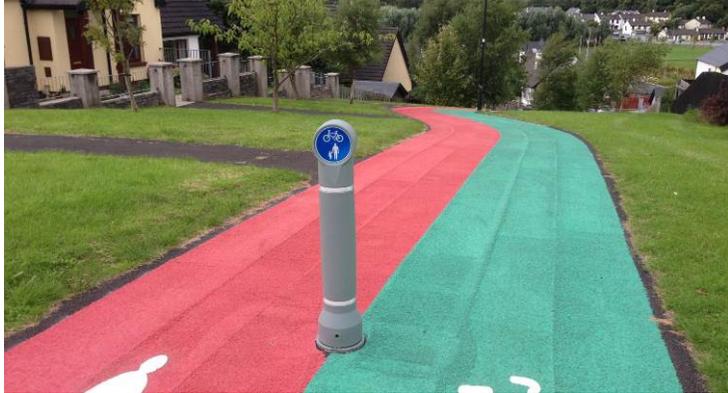
<p>Very steep gradient through estate &amp; no signage</p>	<p>Consideration should be given to some form of guard-railing or hand-railing along the greenway to act as a barrier with which to slow cyclists and to aid pedestrians walking up the hill against the gradient.</p> <p>Greenway signage should be provided at various locations within the estates to guide and direct greenway users.</p> <p>Warning signage should be erected on estate roads in advance of greenway crossover points to warn vehicle drivers of the potential for cyclists and pedestrians to emerge.</p>

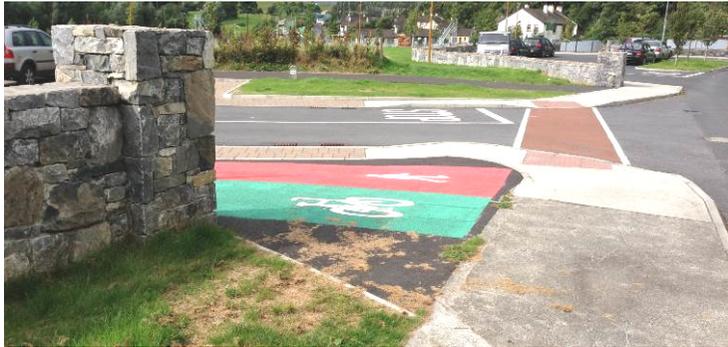
<p>Greenway ends at Gaelscoil/Fairways Junction. No signage</p>

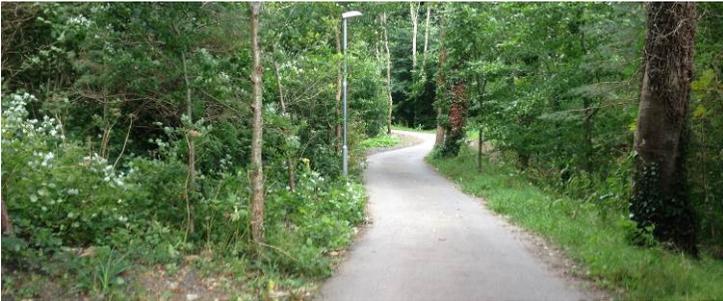
<p>Steep gradient in southern direction towards Lidl.</p>
