S2S Cycle & Footway Interim Works Bull Road to Causeway Road

Stage 3 Road Safety Audit

August 2017

Dublin City Council

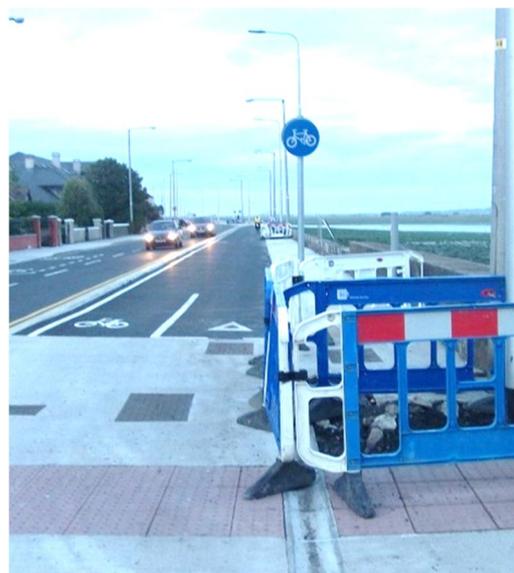
2.1.6 Problem (G6) Signage at exit from Shared Areas

The auditors noticed several instances of pedestrians entering into the cycle track, causing cyclists to swerve to avoid them. It was also noted that sign face RUS 009 has been provided at the exit from all of the shared areas. This sign indicates Pedal Cycles only and prohibits all VEHICLES from entering the cycle track.

The audit team are concerned that there may be confusion amongst pedestrians regarding the correct (and safe) side of the route upon which to travel. This problem could be exacerbated by the use of the incorrect signage.

The audit team recommend that, where appropriate, the RUS 009 signs are replaced by RUS 058CL or RUS 058CR, as these signs indicate the correct side of the route for pedestrians to take.

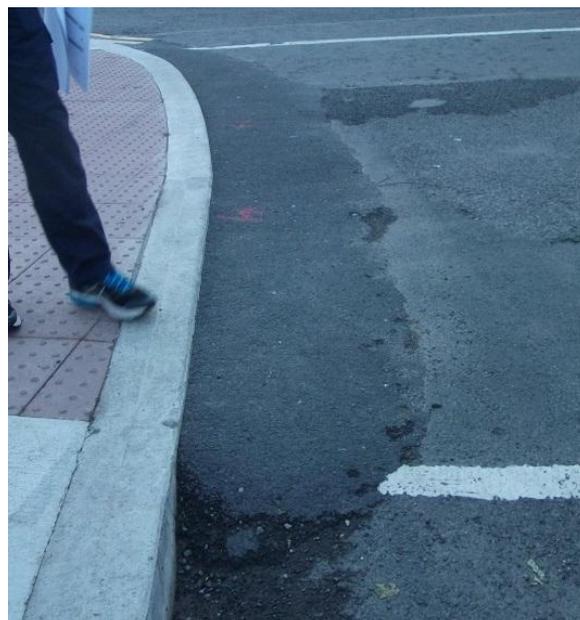
2.2.4 Problem (S4) No Dropped Kerbs at Crossing on Bull Road

The auditors noted there are no dropped kerbs provided at the crossing on Bull Rd, a temporary surfacing has been provided. In the absence of the appropriately constructed dropped kerbs all pedestrians including visually and mobility impaired pedestrians and cyclists may encounter difficulties navigating the route. This could lead to trip/slip hazards for pedestrians

or loss of control incidents for cyclists should they try to navigate a full height kerb.

It is recommended that appropriately constructed dropped kerbs are provided at the crossing location.

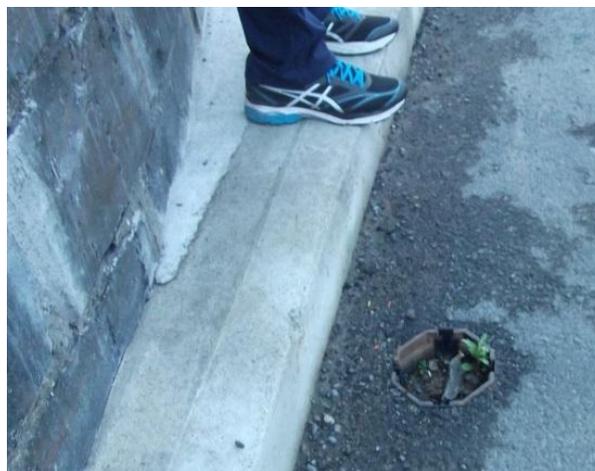
2.2.6 Problem (S6) Redundant Inductive Loop Box at Crossing on Bull Road

There is a redundant loop box on approach to the crossing on Bull Road. This presents a trip hazard for pedestrians or could result in loss of control incidents to for cyclists should they hit a low point unexpectedly.

Remove the loop box and finish the carriageway to an appropriate standard.

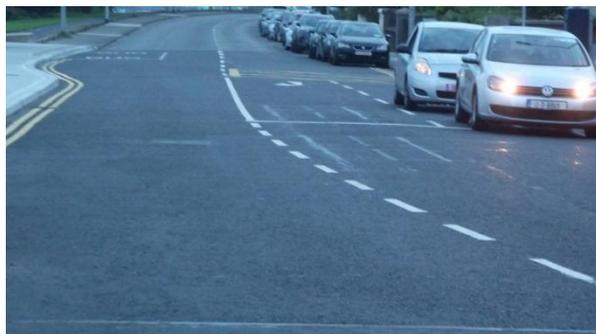
2.2.10 Problem (S10) Southwestern Arm of Bull Rd/Clontarf Rd junction

During the site audit the audit team observed several instances of vehicles crossing over the carriageway centre line to wait for a gap in opposing traffic before undertaking the right turn

into Bull Rd. There is potential for conflict between vehicles travelling southwest bound through the junction and these vehicles that have encroached over the carriageway centreline.

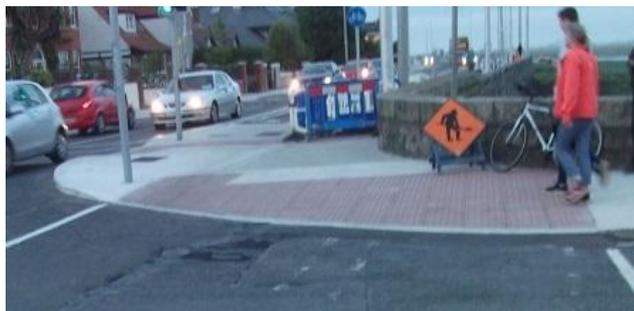
2.2.13 Problem (S13) North-Eastern Crossing Location at Bull Rd/Clontarf Rd junction

During the site visit the audit team noted the incorrect layout of tactile paving the toucan crossing (i.e. the stem is too short). In the absence

of the appropriate tactile paving visually impaired may encounter difficulties in locating the crossing point or they may enter into the road carriageway come into conflict with moving vehicles and cyclists.

It is recommended that appropriate tactile paving is provided to guide vulnerable road users along the most appropriate route.

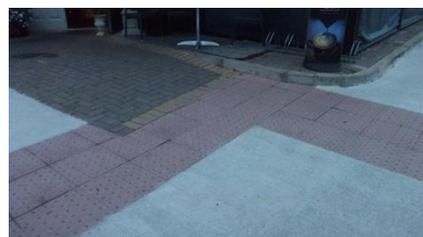
2.2.21 Problem (S21) Dollymount Park Pedestrian Crossing

During the site visit the audit team noted that the layout of the stem of the tactile paving at the northern side of the crossing is incorrect. This could result in visually impaired pedestrians encountering difficulties in locating the crossing point or could result in personal injury should they trip at the full height kerb.

As soon as the opportunity arises, the stem of the tactile paving should be extended to the back of the footway.

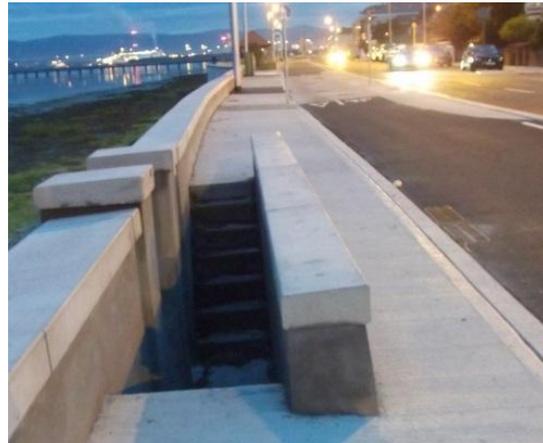
2.2.27 Problem (S27) Narrow Footway at Steps

Due to the narrow footway width at the steps pedestrians may be forced to enter into the adjacent cycle track to pass another pedestrian which could lead to conflict with cyclists/vehicles travelling along the cycle track/road carriageway.

It is recommended that a clear footway width of at least 1200mm (at obstructions only) is provided to ensure pedestrians are not forced to enter the adjacent cycle track to continue their journey.

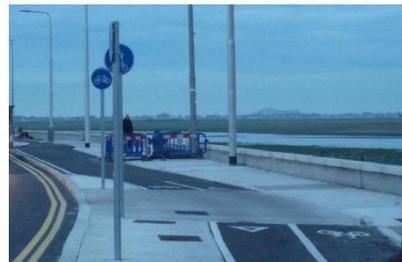
2.2.28 Problem (S28) Blocked Sign face opposite Seafield Rd East Junction

Visibility to the Shared surface sign is blocked by the cycle route sign. As a result, cyclists may be insufficiently advised of the presence of the shared area, the need to reduce speeds and the potential for pedestrians to be present. This could lead to conflict.

Ensure all sign faces are clearly visible to oncoming cyclists.

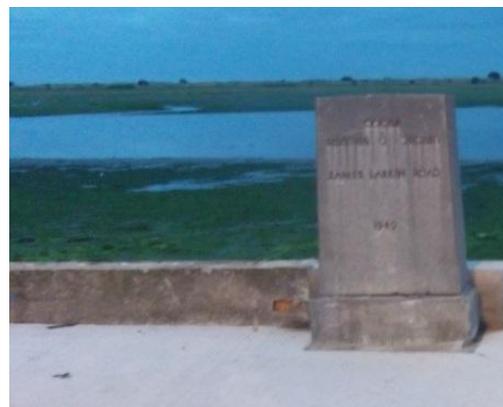
2.2.29 Problem (S29) Low Wall Height – Throughout Scheme

The auditors are concerned about the low sea wall height throughout the scheme and the flat top capping provided, particularly opposite the Mount Prospect Avenue junction (pictured). This presents a hazard to visually both impaired pedestrians (trip hazard) and to children who may be encouraged to run/walk/climb on the wall leading to falls from a height into the sea and/or drowning.

This problem was also noted during the Stage 2 RSA undertaken by PMCE (Problem Ref. 3.1.5).

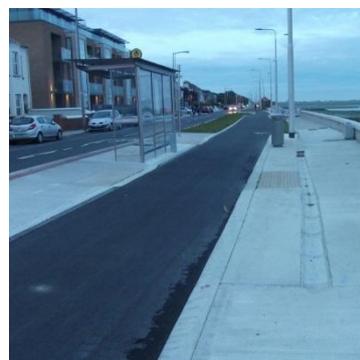
2.2.30 Problem (S30) Drainage Channels Located at Pedestrian Crossings

The audit team noted some instances of the provision of drainage channels immediately to the rear of pedestrian crossing locations. These drainage channels may present a trip hazard to visually impaired pedestrians as they expectantly encounter the channel upon undertaking the crossing. Or a slip hazard or all pedestrians could arise if the channel is full of water during wet or icy weather conditions.

Monitor the situation, if issues arise relocate the pedestrian crossing. Ensure the drainage channel can adequately shed surface water during poor weather conditions.

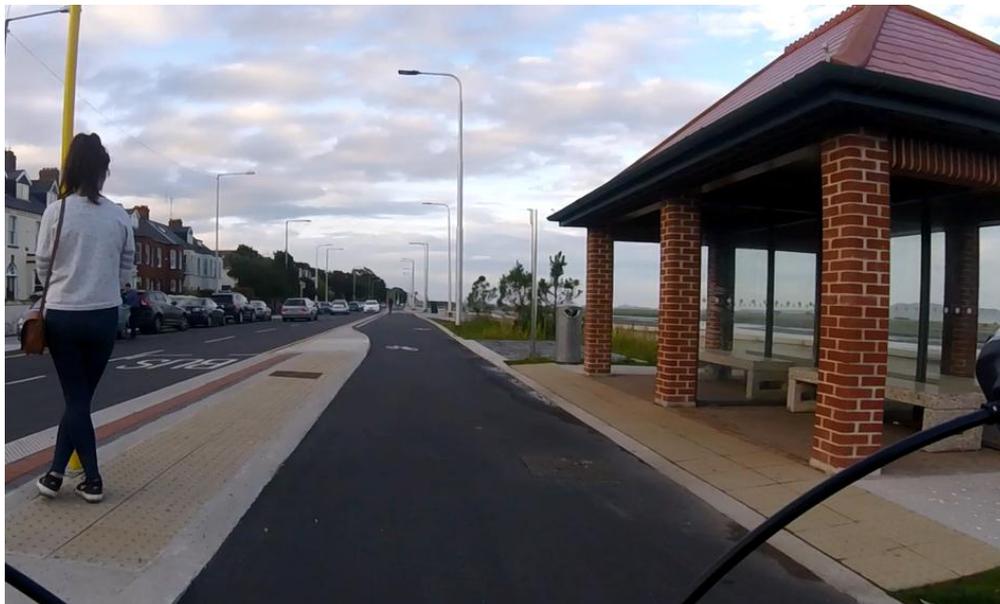
2.2.32 Problem (S32) Bus Stop on Clontarf Rd opposite Doyles Lane

The auditors have concerns regarding the narrow width of island/refuge area provided at the bus stop. Failure to provide a sufficient width of refuge may result in pedestrians encroaching into the adjacent cycle route, leading to conflict.

Monitor the situation, should the bus stop be utilised by high passenger numbers, either the refuge area should be widened accordingly; or cyclists are brought to the rear of the bus stop at appropriate transition points.

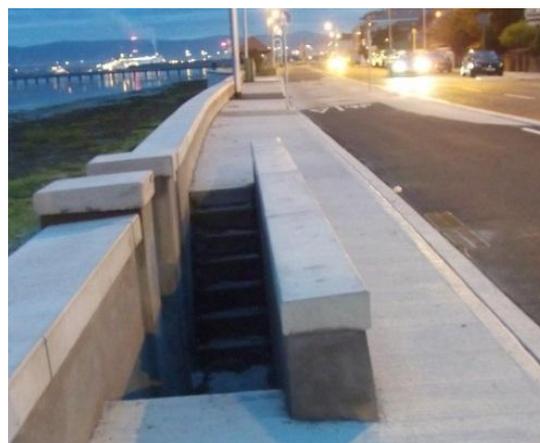
2.2.33 Problem (S33) Narrow Footway at Steps

There is no corduroy hazard warning paving provided at the top of the steps warn visually impaired pedestrians of the presence of the hazards. This could lead to them expectantly proceeding into the steps and subsequently falling down the steps.

Provide the corduroy hazard warning paving at the top of the steps.

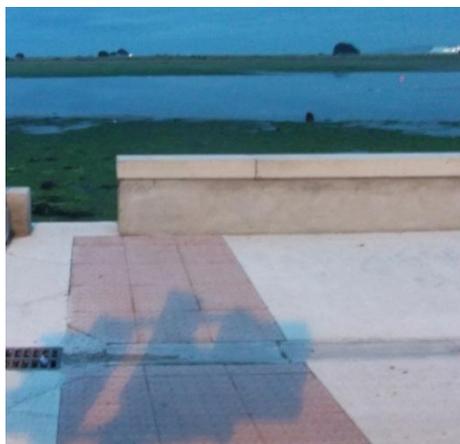
2.2.39 Problem (S39) Gap in Sea Wall at Mount Prospect Ave Junction

There is a gap in the sea wall opposite the Mount Prospect Avenue junction. This could lead to visually impaired pedestrians crossing the road carriageway and proceeding straight to the gap in the wall, resulting in falls and potential drowning.

This problem was also noted during the Stage 1 RSA undertaken by Roughan & O'Donovan (Item No. 5).

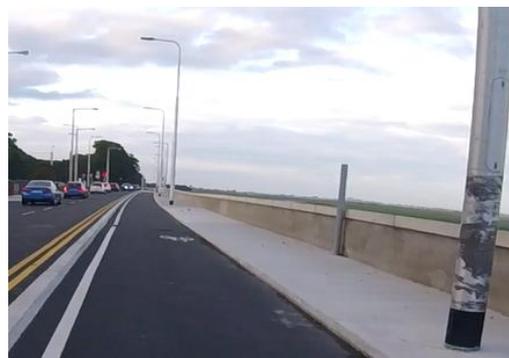
3.1.2 Comment (C2)

The auditors noted the provision of short poles along the edges of the footway. It is unclear to the auditors what the purpose of these poles is. Should they be unnecessary they should be removed to prevent clutter/over proliferation of sign poles.

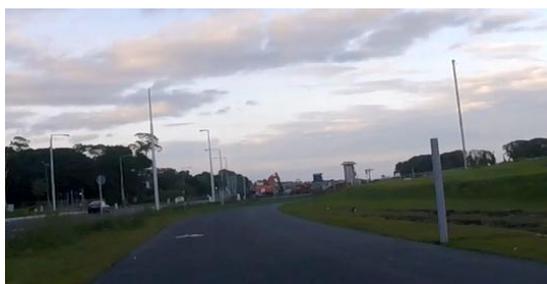
3.1.3 Comment (C3)

There is a sign pole located directly adjacent to the Cycle Track (south of Causeway Rd junction). There should be a gap of at least 500mm between the edge of the cycle track and any street furniture. Further to C2 above, if the sign is unnecessary remove it or relocate to a more suitable location.
