Red Light Camera  
Blackhall Place, Dublin  
Pilot Programme – Phase 3

Closure Report (*DRAFT*)  
April 2016

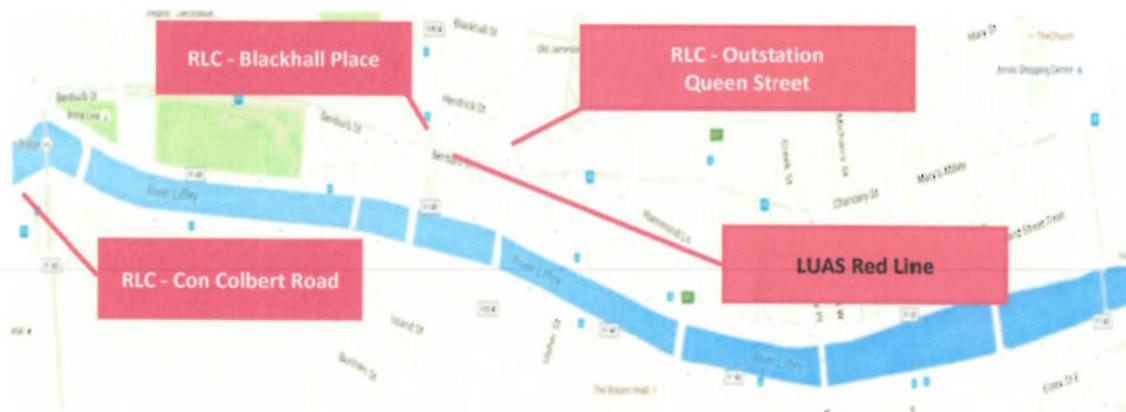
Figure 7 - Locations of Red Light Camera Installations

In July 2010 the Elmore Group Limited was awarded a contract by DCC to install Red Light Cameras at Blackhall Place southbound- (north of junction with Benburb St) and on Con Colbert Road eastbound – (west of junction with South Circular Road). A Red Light Camera outstation (which is a housing only and hence capable of transferring a camera unit) was installed on Queen St (southbound) - north of junction with Benburb St.
