***Cycling Infrastructure Audit***

***Westport Smarter Travel – Cycling Audit Report***

**November 2013**

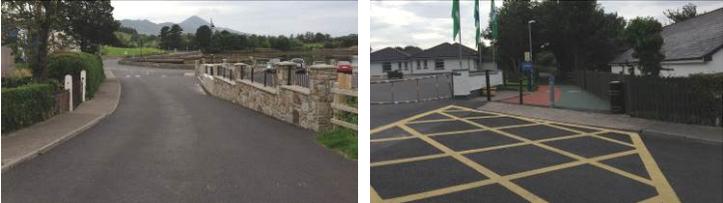
Ref.	Location	Problem	Photograph	Remedial Measure
1.	Westport Quay National School – start/end point of greenway	<p>1. There is no information or directional signage for users leaving the greenway to Westport Quay and beyond.</p> <p>2. There is also little information in terms of signage in the Westport Quay area to direct pedestrians &amp; cyclists to the greenway.</p>

<p>Lack of information and directional signage at the start/end of the greenway to Westport Quay</p>	<p>Signage should be erected at the start/end of the greenway and also along Westport Quay to guide greenway users. The signage should be clear and concise and consistent with greenway signage used elsewhere.</p>

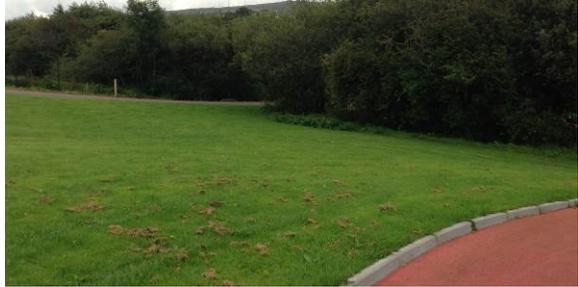
<p>Steep gradient on approach to greenway.</p>	<p>Direction and information signage should be erected at the junction with the estate link displaying the estate name and the direction to the town centre and the Quay as well as distances to each.</p> <p>The site visit noted that there is another greenway link to Ocean View/Woodpark estates in close proximity to the link to Harbour Village. The possibility of combining the two links into one link from the greenway in order to reduce the steepness of the link approaches to the greenway should be considered.</p>

<p>If it is not possible to realign the two links then guard-railing (at junction) and/or fencing (opposite T-junction) should be provided at the spur link junction with the greenway to prevent cyclists overshooting on approach and coming into conflict.</p>

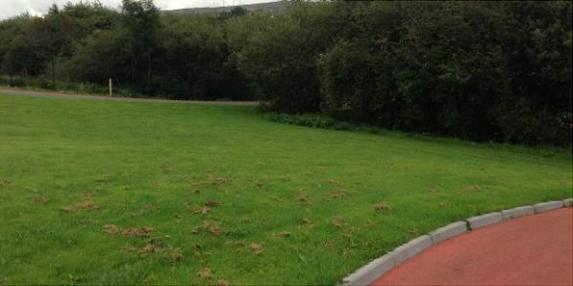
<p>Blue Ped/Cycle symbol missing - Inadequate drop kerb</p>	<p>Direction and information signage should be erected at the junction with the estate link displaying the estate name and the direction to the town centre and the Quay as well as distances to each.</p> <p>There is another greenway link to the Harbour Village estate in close proximity to the link to Ocean View/Woodpark. The possibility of combining the two links into one link from the greenway to reduce the steepness of the link approaches should be considered.</p>

<p>If it is not possible to realign the two links then guard-railing (at junction) and/or fencing (opposite T-junction) should be provided at the link junction with the greenway to prevent cyclists overshooting on approach.</p> <p>Investigation of the pavement cracking and embankment slippage is required and repairs should be carried out.</p> <p>The missing shared space symbol should be provided on all greenway bollards and an adequate drop kerb should be provided at the location described.</p>

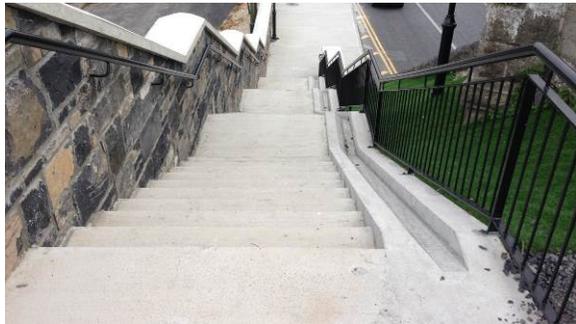
<p>No direction or information signage at steps. Layout of steps does not facilitate a cyclist.</p>	<p>Direction and information signage should be erected on the greenway providing information on where the steps connect to.</p> <p>A bicycle friendly 'groove' could be provided adjacent to the steps to aid a cyclist pushing a bike up/down the steps (example below).</p>

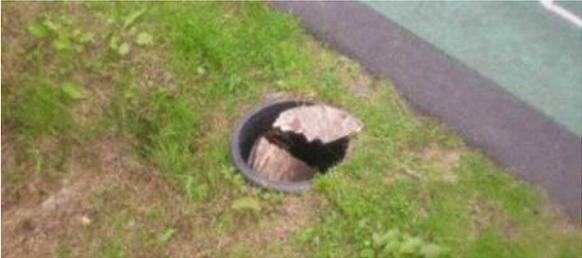
<p>Sleeve hole left exposed</p>	<p>Direction and information signage should be erected at the link junction with the greenway.</p> <p>Guard-railing should be provided at the link junction with the greenway to prevent cyclists overshooting on approach and coming into conflict.</p> <p>A drop kerb should be provided across the greenway link within Monastery View.</p> <p>Cover exposed hole or finish intended works.</p>

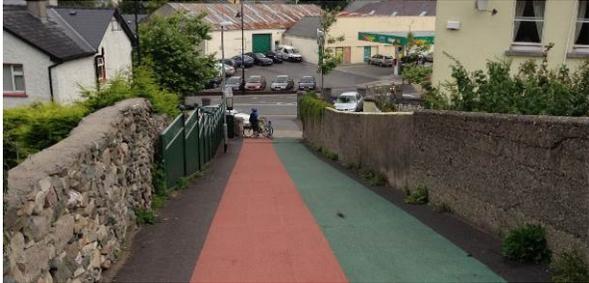
<p>Dangerous merge onto Altamount St/car park with very limited exiting visibility</p>	<p>Direction and information signage should be erected on the greenway and also on Altamount St and within the car park.</p> <p>Hand-railing should be erected along the full length of the link ramp to aid pedestrians.</p> <p>Guard-railing should be considered at various locations along the link ramp to prevent cyclists from travelling at high speed. Signs advising cyclists to dismount their bicycles at the top of the link ramp should also be considered.</p>

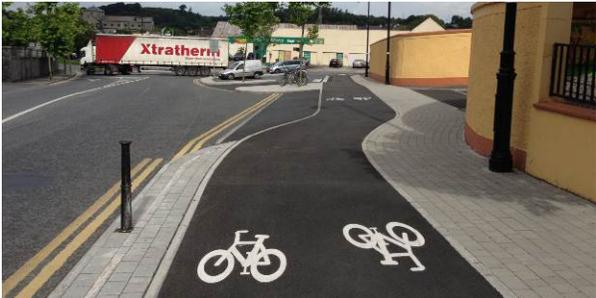
3.	Altamount Street – link between crossing and Mill Road	<p>There is no way-finding signage provided between the crossing on Altamount Street and Mill Road to guide greenway users to the two greenways. The junction of Mill Road and Distillery Road is particularly poor in this regard with only one small brown sign provided behind a</p>

<p>No greenway signage on Altamount Street</p>	<p>Greenway way-finding signage should be provided at the junction of Mill Road/Distillery Road and also on Altamount St to guide greenway users to the greenways separated by Altamount Street.</p>

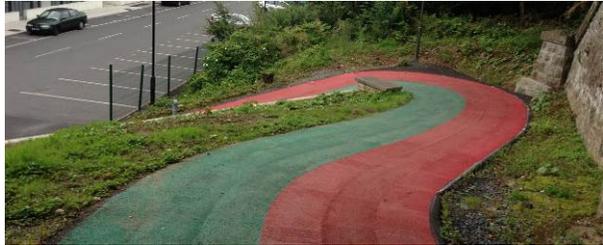
<p>Steep gradient on approach to Riverside development. Embankments exposed.</p>

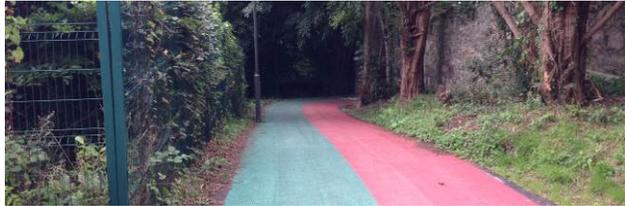
<p>Steep gradient on approach to junction on greenway. Poor forward visibility due to high boundary wall.</p>	<p>Direction and information signage should be erected on the greenway at the link junction.</p> <p>Hand-railing should be erected along the full length of the link ramp down to the apartments and retail park to aid pedestrians.</p> <p>Guard-railing should be considered at various locations along the greenway and link ramp to prevent cyclists from travelling at high speed. Signs advising direction of travel should be erected in advance of blind turns and at junctions.</p>

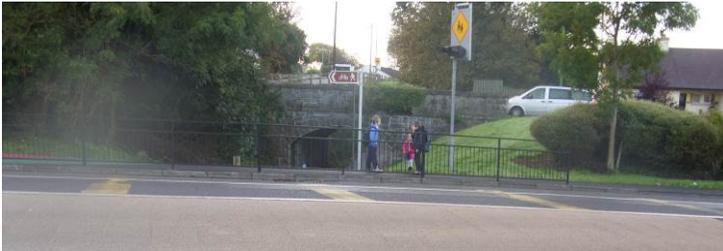
Ref.	Location	Problem	Photograph	Remedial Measure
9.	N5 Crossing	<p>The Audit Team welcomes the provision of the new toucan crossing and guard-railing. Although the crossing is positioned away from the direct route desire line across the N5, the guard-railing should prove effective in directing users to the crossing and discouraging uncontrolled movement</p> <p>Notwithstanding this, signage in the vicinity of the crossing is poor and inconsistent. There is no sign stating the name and direction to the town greenway or the Great Western Greenway and different types of sign are used on both sides of the N5 which are not consistent with signage used elsewhere. Signage is important at this location as the greenway does not continue on Carrowbeg Estate Road at present.</p>

<p>Brown background sign with symbols only</p>

<p>Informal 'sketched' sign showing direction to greenway</p>	<p>Signage at this location should be reviewed and new signs should be provided on both sides of the N5 which is clear and consistent with signage used elsewhere.</p> <p>Consideration should be given to extending the guard-railing along the footpath on the southern side of the N5 to deter greenway users from taking a more direct line across the N5 away from the controlled crossing.</p>

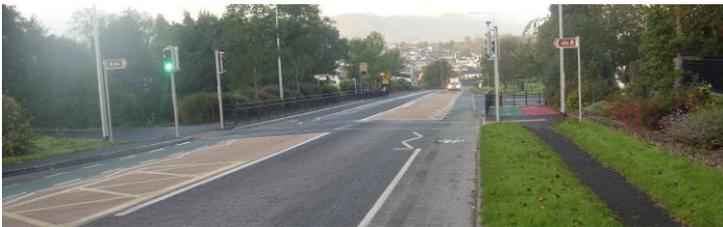
<p>Brown background signage with symbols only at crossing</p>

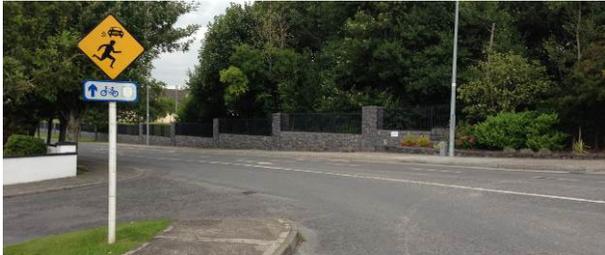
<p>White background sign with symbols only</p>

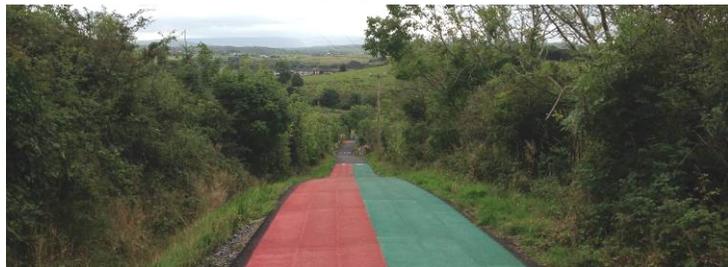
<p>Very steep gradient south of junction</p>	<p>Direction and information signage should be rationalised at the junction to address the problems raised.</p> <p>Guard-railing should be considered at various locations along the greenway to the south of the junction to prevent cyclists from gaining very high speeds and potentially coming into conflict with other greenway users travelling up or down the hill.</p>

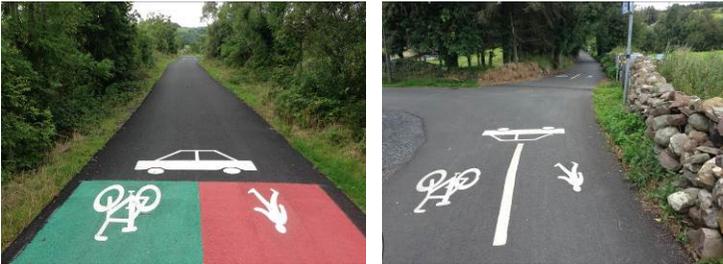
Ref.	Location	Problem	Photograph	Remedial Measure
3.	Northern section of greenway – shared between cars, cyclists and peds	<p>This section of greenway is shared with motor vehicles as there are a number of private residential and farm accesses on the route. However, car symbols are only shown on the greenway at both ends of this section whereas there a number of cycle and pedestrian logo markings scattered along the route. In addition, there are no warning signs of cars or farm machinery using the route. The result is that the user is not fully aware at all times of the risk of meeting a motor vehicle on the route.</p>

<p>Car vehicle road markings at both ends only</p>	<p>Erect warning signage and provide more road markings as per the markings shown in the photos regarding the shared use of the greenway pavement.</p>

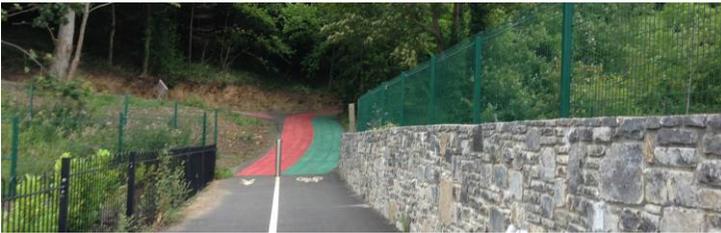
Ref.	Location	Problem	Photograph	Remedial Measure
3.	Greenway Junction on hill behind Lidl	The greenway splits in two directions at this location but there is no direction or information signage provided for each direction.

<p data-bbox="741 488 1256 517">No signage provided at greenway junction.</p>	Erect greenway direction signage at this location which is consistent with greenway signage provided elsewhere.

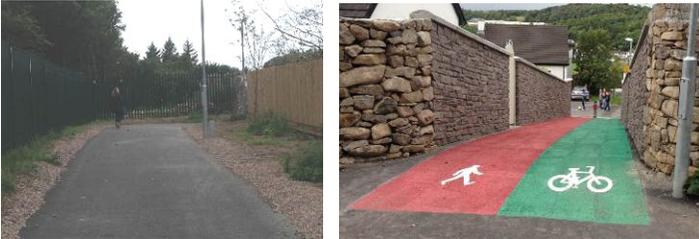
4.	Fairways/ Páirc na Coille link at top of hill behind Lidl	1. There is no direction or information signage at the link with the greenway stating that the link is to a residential area or providing the name of the residential area.

<p data-bbox="741 807 1368 836">No signage providing information to greenway user.</p>	Signage should be provided on the greenway at the entrance to the residential area stating the name of the area and direction to key trip generators such as the school, Great Western Greenway etc.

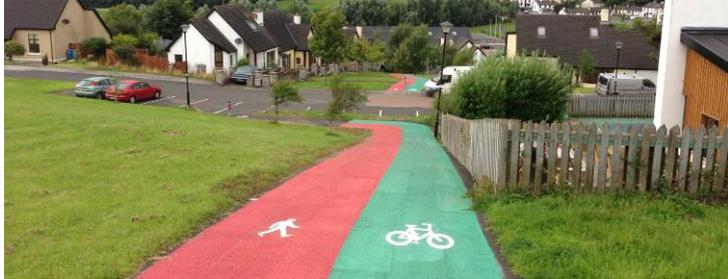
<p>Very steep gradient through estate &amp; no signage</p>

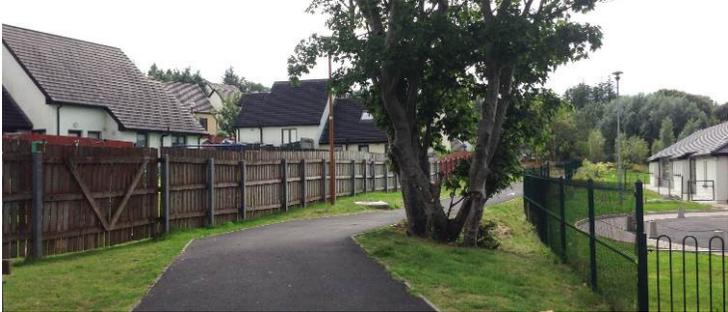
<p>No greenway signage or markings in the vicinity of the Gaelscoil</p>	<p>Greenway signs and markings should be provided in the vicinity of the school to inform greenway visitors in particular of the direction to key onward journey locations such as the Great Western Greenway, Westport town centre etc.</p>

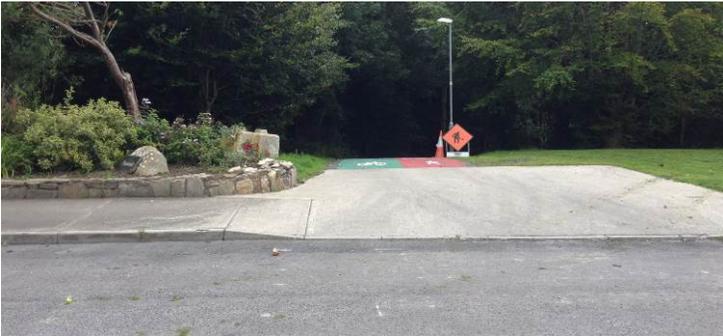
Ref.	Location	Problem	Photograph	Remedial Measure
8.	Start/End of Greenway at Pinewoods Estate	The start/end of the greenway within Pinewoods is very poorly signed and 'advertised' to the general public. There is no direction or information signage at the Pinewoods junction with the N59 or at the greenway within Pinewoods to inform the public of the presence and location of the greenway and the direction to key locations. The greenway shared ped/cyclist bollard is also missing.

<p data-bbox="741 595 1413 624">No signage and missing greenway bollard at Pinewoods</p>	<p data-bbox="1496 248 2051 339">Erect greenway signage and the greenway shared space bollard at the start/end point of the greenway within Pinewoods.</p> <p data-bbox="1496 368 2051 491">Consideration should also be given to signage at the Pinewoods junction with the N59 to inform passing pedestrians and cyclists of the location of the greenway.</p>

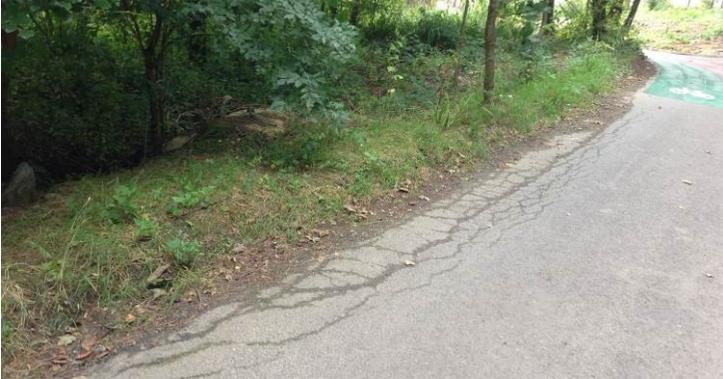
Ref.	Location	Problem	Photograph	Remedial Measure
9.	Greenway running between Pinewoods and Lidl	<p>1. The gradient of the greenway slopes steeply in the eastern direction towards Lidl. There is a high risk that cyclists will gain high speed on the greenway and come into conflict with other pedestrians and cyclists on the greenway. There is also the risk of overshooting corners.</p> <p>2. The embankment on the eastern side of the greenway is starting to settle causing pavement cracking. This is also resulting in a narrowing of the effective path width.</p>

<p>Pavement cracking due to embankment settling.</p>	<p>Consideration should be given to some form of guard-railing or hand-railing along the greenway to act as a barrier with which to slow cyclists and to aid pedestrians walking up the hill against the gradient.</p> <p>The greenway embankment should be closely monitored for any further settling. Remedial works should be carried out on the existing pavement.</p>

Pavement Condition (PCI Range) – in the absence of carrying out any detailed pavement analysis calculations, site visits noted that the condition of the greenway pavement surface is generally good representing an estimated PCI Range greater than or equal to Level B. There are two locations where the pavement is at risk of failure due to settling and slipping of the adjacent embankment and this should be closely monitored and repairs carried out.
