S2S Cycle & Footway Interim Works Bull Road to Causeway Road

Stage 3 Road Safety Audit

August 2017

Dublin City Council

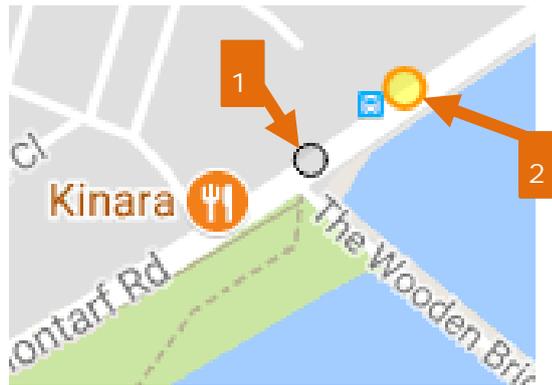
Bull Road/Clontarf Rd Junction

1.6.3 Two incidents have arisen within direct proximity of the Bull Road/Clontarf Rd junction within the nine-year period (2005-2013). Neither of these incidents involved Pedestrians, with one being a minor incident, and the other being a serious 'single vehicle only' incident.

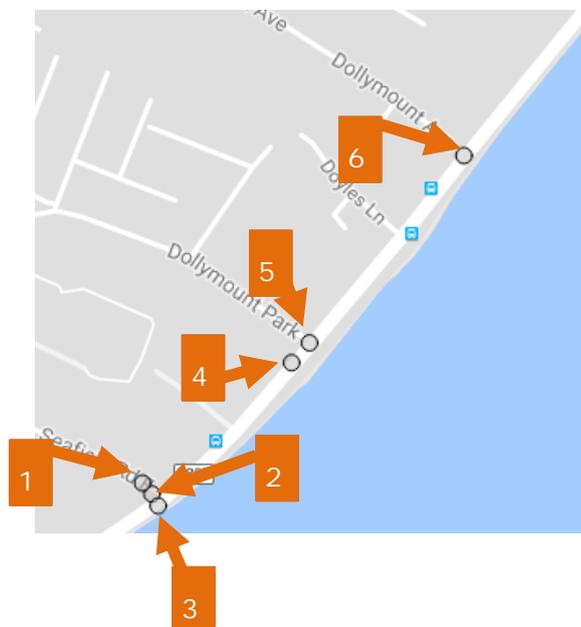
Seafield Road East to Clontarf Road Junctions

1.6.4 Three number minor incidents were recorded at the Seafield Road/Clontarf Rd junction, one of which involved a pedestrian over the nine-year period under consideration.

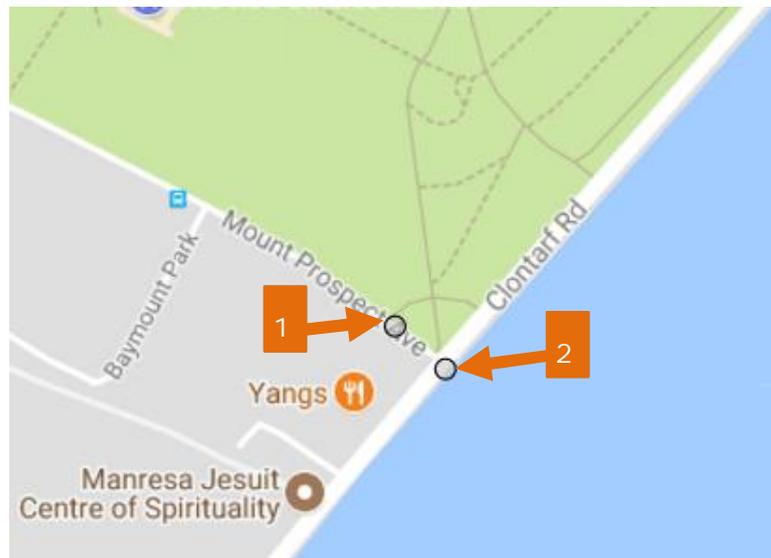
Mount Prospect Avenue/Clontarf Rd Junction

1.6.5 Two minor incidents occurred at/on approach to the Mount Prospect Avenue junction during the nine-year period under consideration (2005-2013). The first incident is cited involving a car with circumstances of 'other'. The second incident occurred on the Clontarf road and its circumstances were 'rear end'.

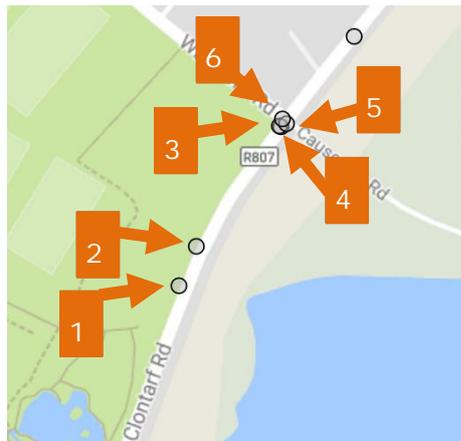
Clontarf Rd/Watermill Rd/Causeway Rd/James Larkin Rd Junction

- 1.6.6 There were four number recorded collisions at the Clontarf Rd/Watermill Rd/Causeway Rd/James Larkin Rd Junction. Two collisions involved vehicles undertaking right turn manoeuvres.
- 1.6.7 There was one collision involving a cyclist on Clontarf Rd however the circumstances are unknown.
- 1.6.8 The review of the RSA data reveals that there are no apparent trends between the collisions which have occurred during the most recent 9-year period (2005-2013).
